# Americas Hometenders

## CONFIDENTIAL INSPECTION REPORT

1567 Catamaran Way, Laguna Niguel, CA

12/15/2009 2:00 pm to 6:00 pm

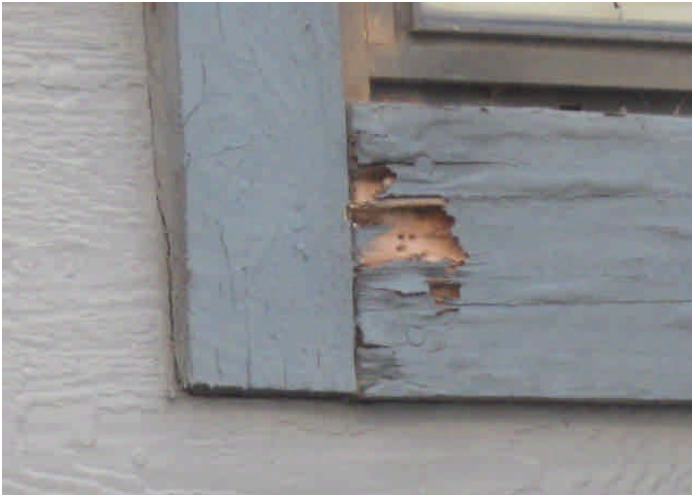
- Siding and wood trim have some deterioration, paint peel and joints that are not sealed and could allow for moisture penetration, recommend further evaluation by the termite inspector and servicing of any area that allows for possible moisture intrusion that could cause damage.

Siding has some paint peel and joints that are not sealed could allow for some moisture penetration - *Continued*

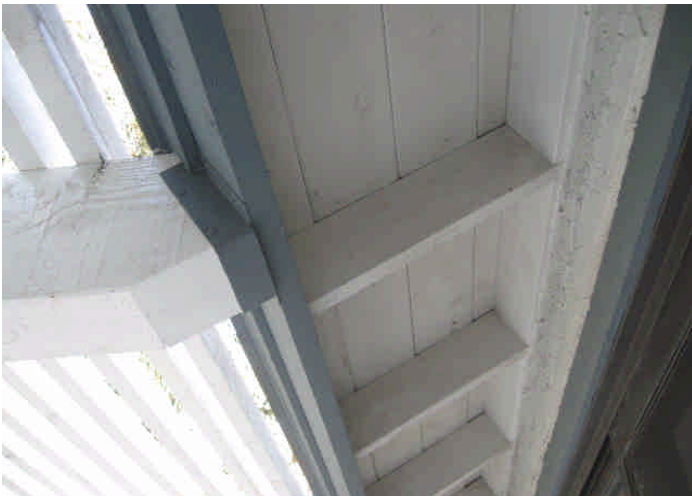
1.4 - → The wood deck shade cover is properly anchored to the roof fascia board but the fascia board at the deck shade cover is not anchored to the rafter tails and is recommended to have the appropriate rafter tails Simpson bracket anchored to the fascia board to prevent possible displacement during winds or seismic activity.

- Deck and stair railings current construction requirements are for 42 inches in height which is a recommended upgrade in structures built before 2008, however, a requirement in structures 2008 and after.  
*Components and Conditions Needing Service*
- The wood deck shade cover is properly anchored to the roof fascia board but the fascia board at the deck shade cover is not anchored to the rafter tails and is recommended to have the appropriate rafter tails Simpson bracket anchored to the fascia board to prevent possible displacement during winds or seismic activity.

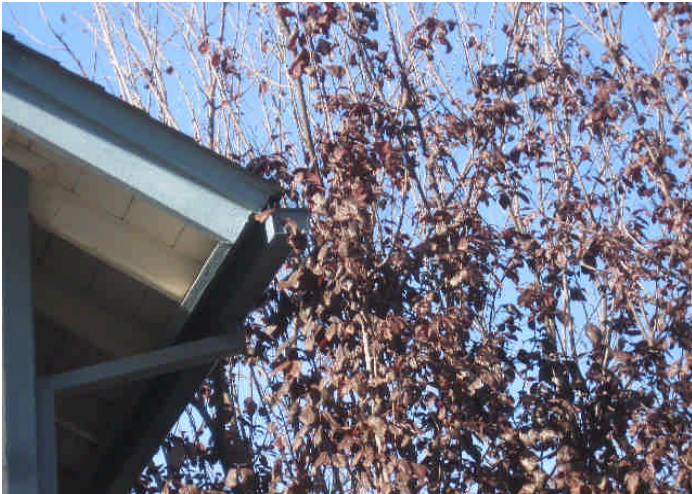
- Vegetation is encroaching on the structure, and should be kept a minimum of twelve inches away for the general welfare of the walls, roof and foundation.
- There are tree limbs overgrowing or against the walls the structure that are recommended be trimmed and monitored, to insure that they do not impact or damage the roof/walls or their components.

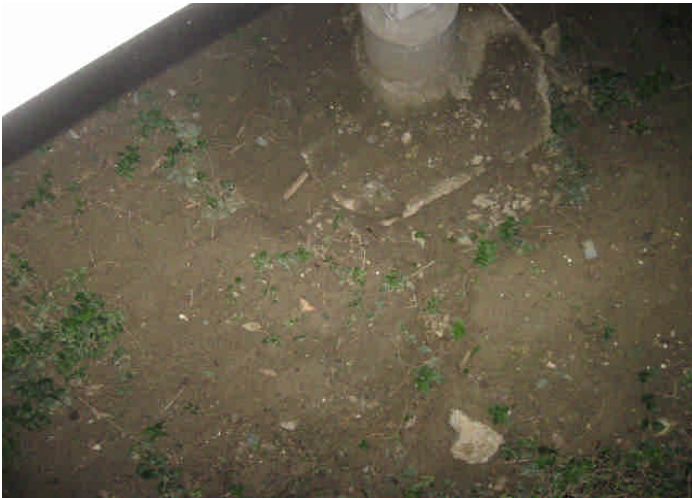
1.12 - → Evidence of erosion on portions of the hillside below the property, recommend further evaluation by appropriate specialists for improving the drainage and the hillside vegetation to protect against erosion. Refer to the CC&Rs and the HOA.

- Evidence of erosion on portions of the hillside below the property, recommend further evaluation by appropriate specialists for improving the drainage and the hillside vegetation to protect against erosion. Refer to the CC&Rs and the HOA.

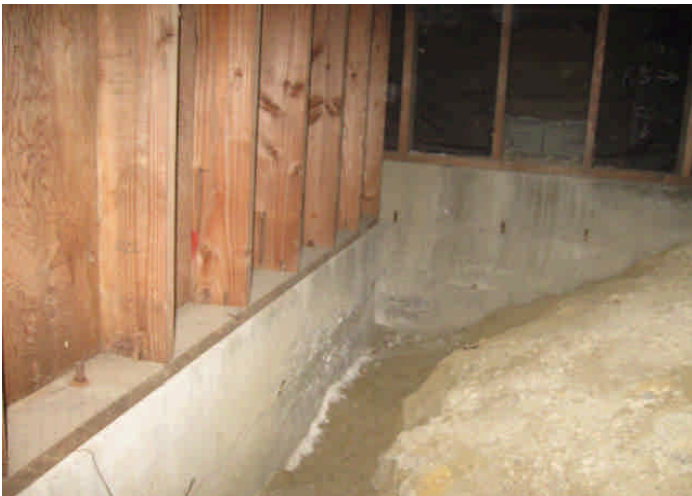
- There is efflorescence on the stem wall in the raised foundation, which confirms that moisture has penetrated the area and activated minerals that form a white powdery formation of salt crystals. This is a condition that should be monitored with evaluation and verification for proper drainage around the exterior of the foundation. This moisture transfer through the concrete and soil is one that could produce musty odors in the home.

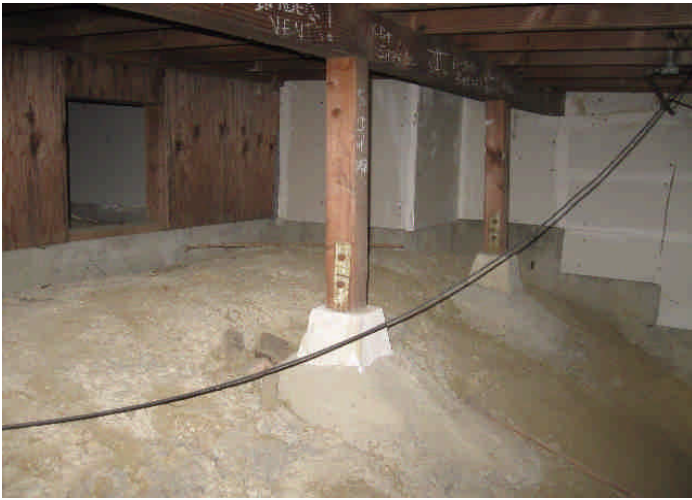
2.1 - ↪ The soils within the crawlspace are moist, which appear to have resulted from over-irrigation, hillside moisture conditions, inadequate ventilation or poor drainage around the foundation. This can contribute to differential settling, and facilitate musty odors and possibly the growth of a variety of molds and fungi that can produce unhealthy conditions. The sprinklers should be adjusted to water less around the foundation flower\grass beds with proper drainage provided around the foundation and the crawlspace should be carefully monitored.

There are moist soils in the foundation crawlspace that appear to be a result of over-irrigation - *Continued*

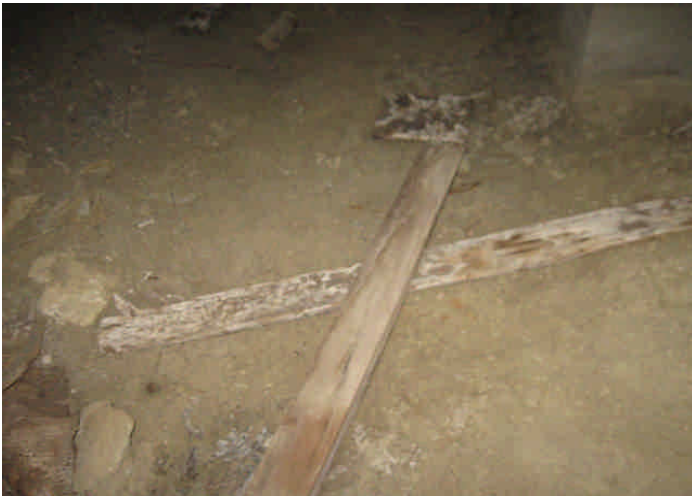
2.2 - ↪ Wood or cellulose debris has been left under the structure and is recommended to be removed. Refer to the termite inspector for further evaluation and corrections.

- Wood or cellulose debris has been left under the structure and is recommended to be removed. Refer to the termite inspector for further evaluation and corrections.

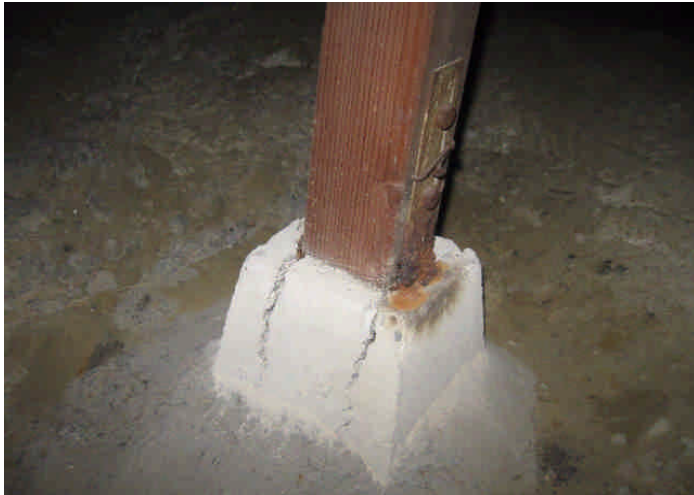
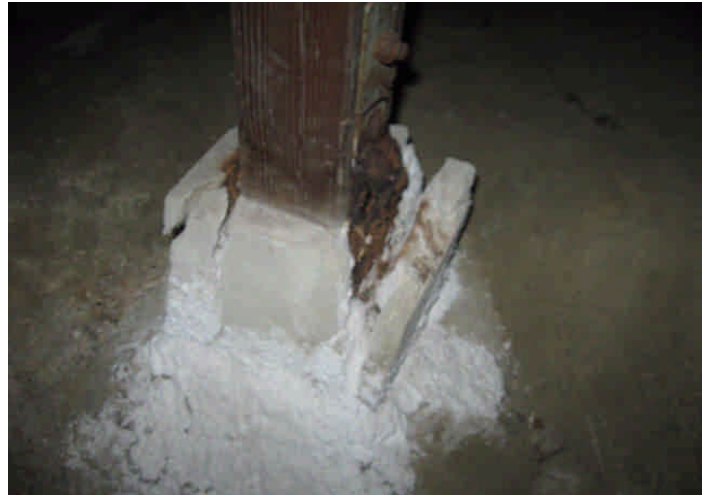
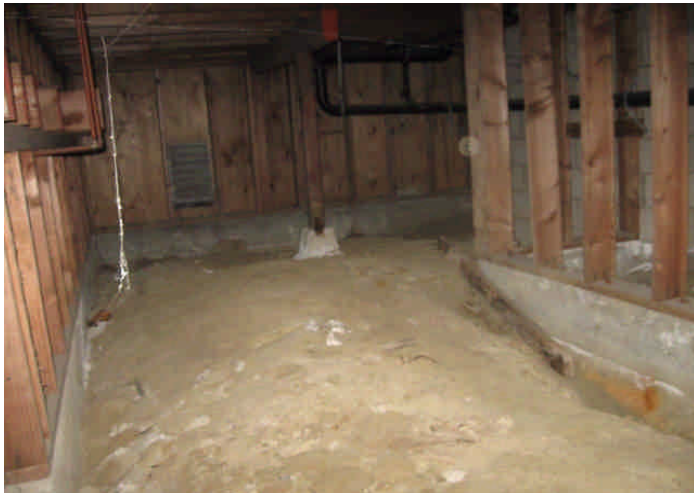
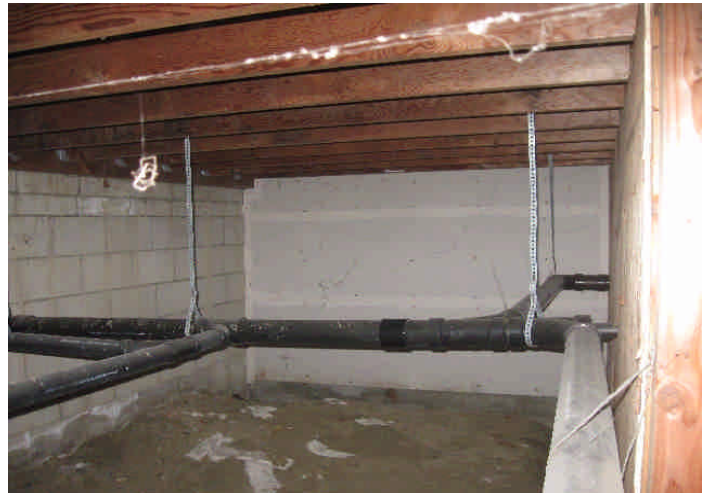
2.3 - ✓ Some of the pier posts did not have damage to the concrete base pads due to the high moisture content in the soil, due to the compartmental design of the areas under the home and the hillside moisture condition, there is inadequate ventilation in the crawlspace under the home, recommend further evaluation by a qualified foundation specialist for corrections and upgrades.

- ✓ Some of the pier posts did not have damage to the concrete base pads due to the high moisture content in the soil, due to the compartmental design of the areas under the home and the hillside moisture condition, there is inadequate ventilation in the crawlspace under the home, recommend further evaluation by a qualified foundation specialist for corrections and upgrades.

Some of the pier posts did not have the proper concrete base pads and were touching the soil in places - *Continued*

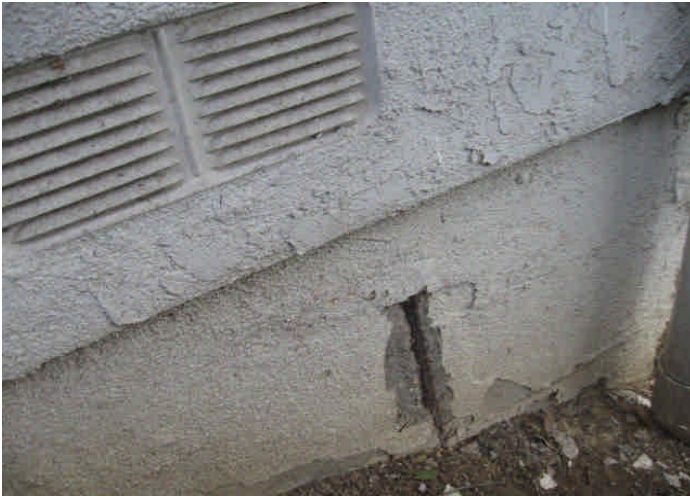
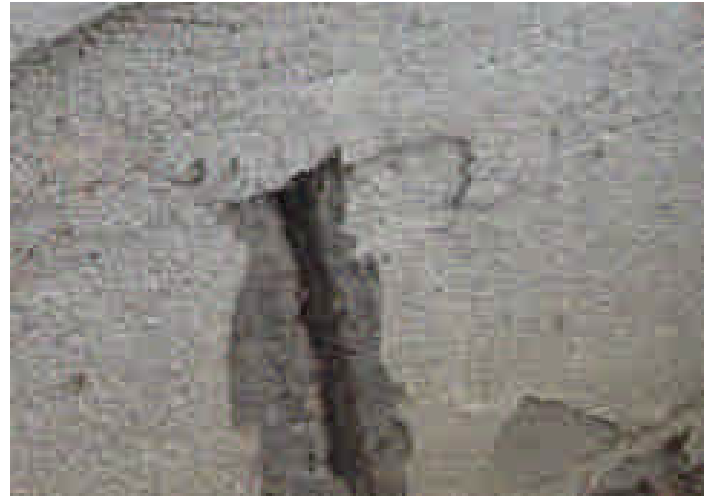
2.5 - ↪ There is a rusted iron rebar break through at the foundation that is recommended to be further evaluated by a foundation specialist for possible repairs. (right side exterior area)

- There is a rusted iron rebar break through at the foundation that is recommended to be further evaluated by a foundation specialist for possible repairs. (right side exterior area)

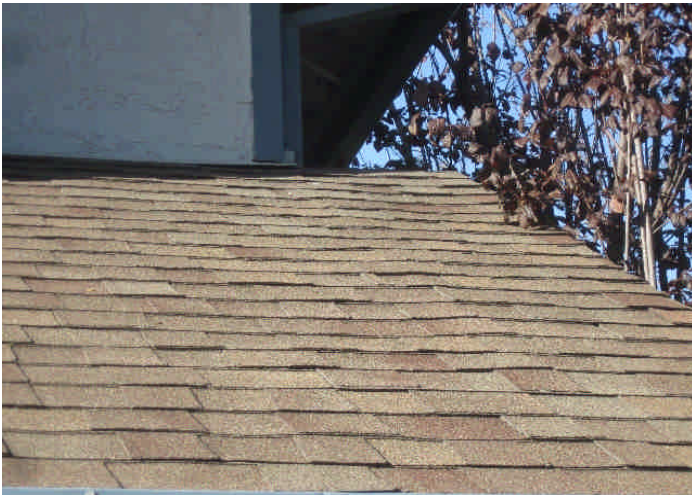
3.2 - ↪ There are tree branches over hanging or against the roof that should be pruned back or removed to prevent damage to the roof and eaves. Recommend further investigation to insure any damage is corrected when branches or vegetation has been removed.

- There are tree branches over hanging or against the roof that should be pruned back or removed to prevent damage to the roof and eaves. Recommend further investigation to insure any damage is corrected when branches or vegetation has been removed.

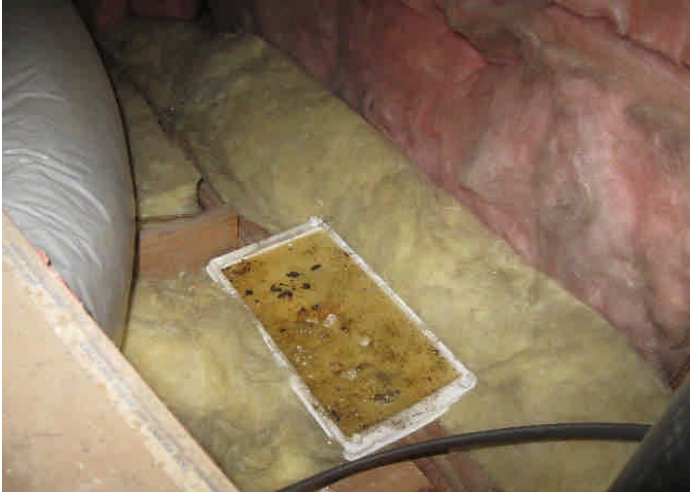
- 3.3 - √ Evidence of rodent droppings in the attic, however, the activity does not appear to be current, recommend further investigation by an appropriate specialist to insure that openings leading to the attic are properly sealed and that any rodent activity has been properly terminated. Recommend any rodent debris be properly cleaned up.

- ✓ Evidence of rodent droppings in the attic, however, the activity does not appear to be current, recommend further investigation by an appropriate specialist to insure that openings leading to the attic are properly sealed and that any rodent activity has been properly terminated. Recommend any rodent debris be properly cleaned up.

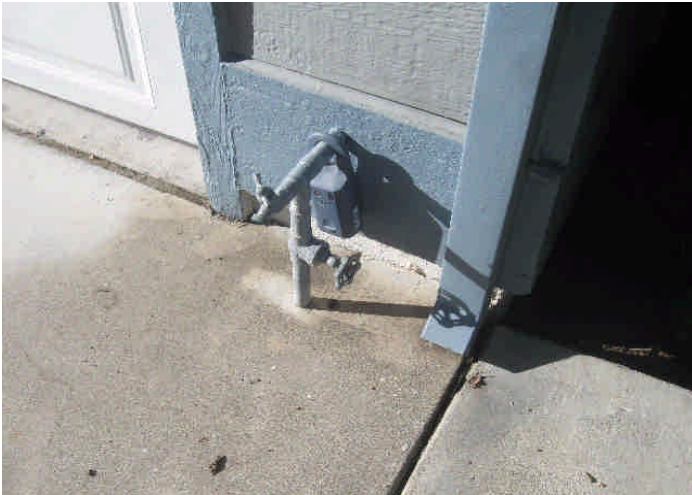
- 5.1 - √ The main water supply piping has a gate valve that is recommended to be upgraded to a ball quarter turn valve, older gate valves tend to leak or malfunction and are not tested. Recommend keeping a water meter key for emergency turn off of entire water supply to the home until the gate valve is replaced.

The main water supply piping has a gate valve that is recommended to be upgraded to a ball valve - *Continued*

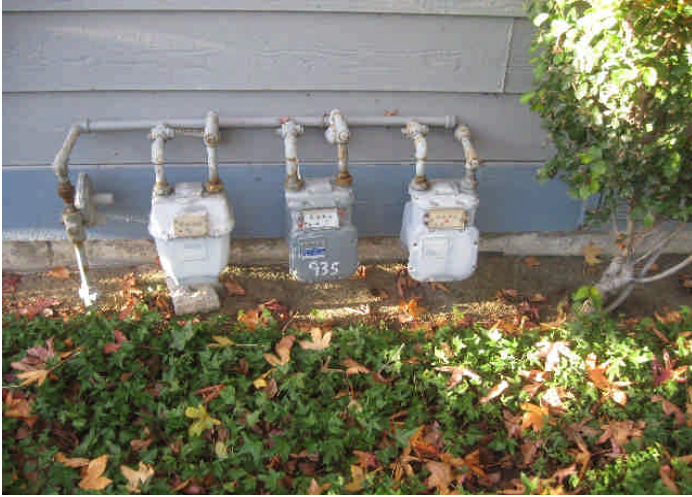
- 5.2 - √ Recommend the gas shut off valve have a wrench located at the shut off valve or a seismic auto shut off valve installed in case of emergency. Some insurance companies are now requiring that an automatic gas shut off gas valve be installed before they will insure you, this should be verified with your insurance company. They cost around \$350 to install. Some City construction jurisdictions require the auto shut off valves when a property is sold, verify with your City or insurance company on requirements before close of escrow. If the wrench only is used, it is recommended that the Gas Company's gas meter valve be verified as easily operated.

- Recommend the gas shut off valve have a wrench located at the shut off valve or a seismic auto shut off valve installed in case of emergency. Some insurance companies are now requiring that an automatic gas shut off gas valve be installed before they will insure you, this should be verified with your insurance company. They cost around \$350 to install. Some City construction jurisdictions require the auto shut off valves when a property is sold, verify with your City or insurance company on requirements before close of escrow. If the wrench only is used, it is recommended that the Gas Company's gas meter valve be verified as easily operated.

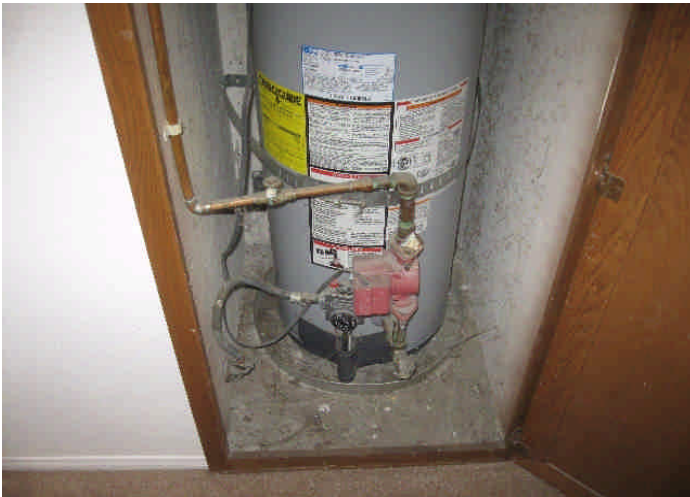
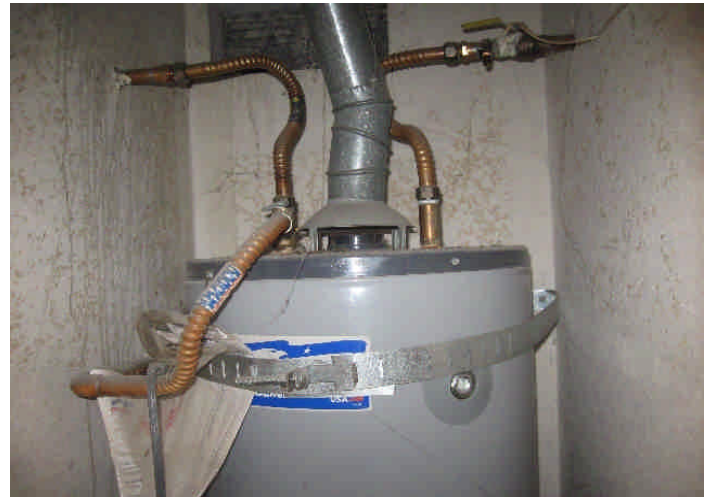
- 5.3 - √ The water heater has the seismic straps in place but is not properly blocked to the wall to prevent seismic slam during earthquake activity. This is typically a manufacturer's installation instruction requirement and is always recommended by this inspector to prevent possible damage to the water or gas lines during seismic activity. This usually is described in the seismic strap kit by the manufacturer along with wrapping the straps around the water heater to prevent side to side motion, and is usually blocking with wood at each strap location between wall and water heater with one inch of non combustible material between the wood and the water heater if it is not a zero clearance model. Verification of zero clearance models is marked on the water heater.

- ∨ The water heater has the seismic straps in place but is not properly blocked to the wall to prevent seismic slam during earthquake activity. This is typically a manufacturer's installation instruction requirement and is always recommended by this inspector to prevent possible damage to the water or gas lines during seismic activity. This usually is described in the seismic strap kit by the manufacturer along with wrapping the straps around the water heater to prevent side to side motion, and is usually blocking with wood at each strap location between wall and water heater with one inch of non combustibile material between the wood and the water heater if it is not a zero clearance model. Verification of zero clearance models is marked on the water heater.

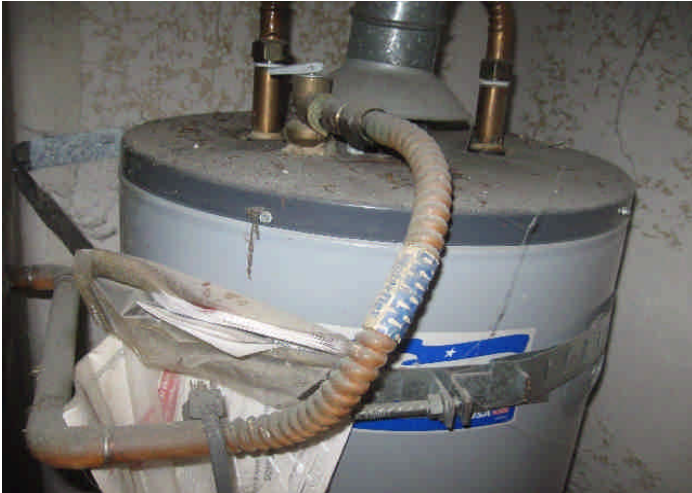
- 5.4 - √ Water heater TPR valve down spout pipe has been improperly installed with a section corrugated flex pipe that is not approved for this use and can create a restriction if the valve releases under steam and pressure, recommend further installation of approved smooth wall pipe such as approved 3/4" copper with positive gravity draining on the down spout pipe extended to a safe exterior location pointed

- The water heater is equipped with a mandated pressure-temperature relief valve.
- Components and Conditions Needing Service*
- ∨ Water heater TPR valve down spout pipe has been improperly installed with a section corrugated flex pipe that is not approved for this use and can create a restriction if the valve releases under steam and pressure,

recommend further installation of approved smooth wall pipe such as approved 3/4" copper with positive gravity draining on the down spout pipe extended to a safe exterior location pointed downward and 6" to 24" above grade.

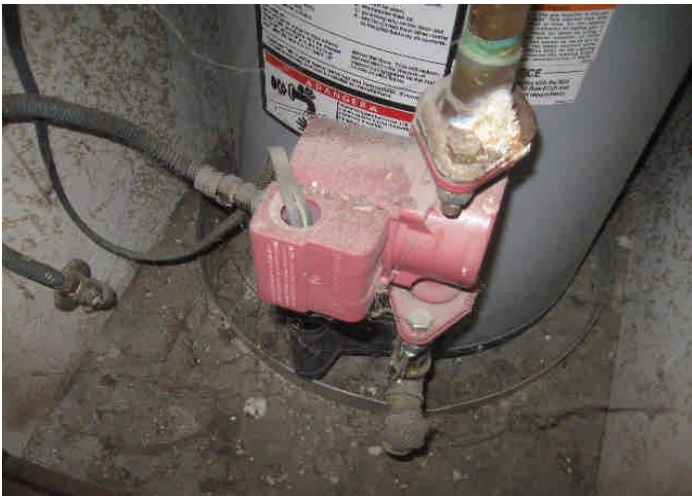
5.5 - ✓ Stress relief clamp on the electric cord of the re circulation pump was missing and is recommended to be installed as required by the National Electric Code.

- ✓ Stress relief clamp on the electric cord of the re circulation pump was missing and is recommended to be installed as required by the National Electric Code.

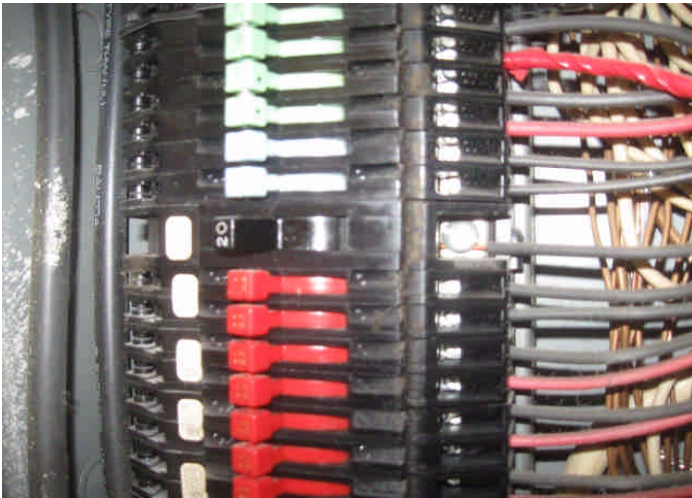
6.3 - ↪ There is a circuit breaker in the electric sub panel that has been replaced with one that is not original type equipment and may not fit the panel properly, the breaker appears to be working, however, this is not a recommended practice and you may want this to be further investigated by an electrical specialist.

- There is a circuit breaker in the electric sub panel that has been replaced with one that is not original type equipment and may not fit the panel properly, the breaker appears to be working, however, this is not a recommended practice and you may want this to be further investigated by an electrical specialist.

There is a circuit breaker in the electric sub panel that has been replaced with one that is not original - *Continued*

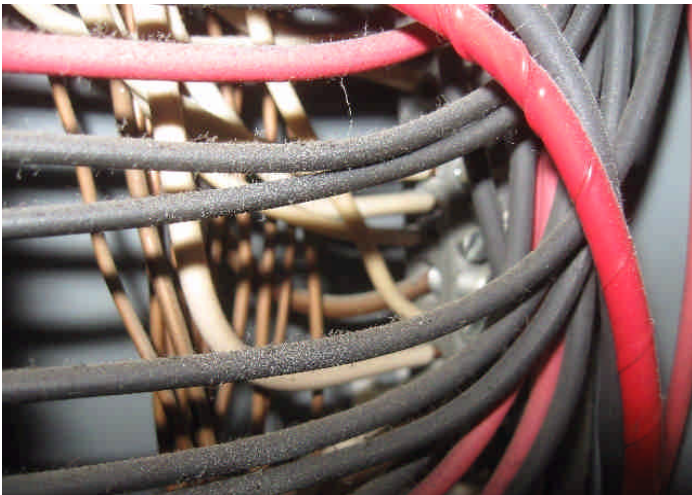
6.4 - ↪ The white wire or neutral buss bar in the sub electric panel is improperly bonded to the panel's box with a flat wire ground and is recommended to be further investigated by an electrical specialist and the ground\bond wire detached from the neutral buss bar.

- The white wire or neutral buss bar in the sub electric panel is improperly bonded to the panel's box with a flat wire ground and is recommended to be further investigated by an electrical specialist and the ground\bond wire detached from the neutral buss bar.

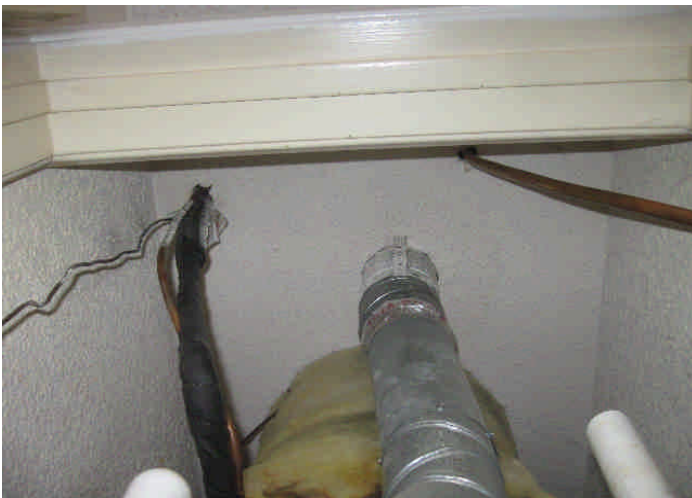
8.2 - ↪ The furnace gas vent pipe penetrates the ceiling drywall without the apparent benefit of a transition housing, double wall, B-vent pipe is required to have 1" clearance to combustible material, drywall is with paper coating is considered a combustible. Sometimes the metal transition housing is covered by drywall compound and not visible, recommend verifying or clearing a one inch space around the vent pipe. Installing a metal cap ring or transitional housing is recommended.

- The furnace gas vent pipe penetrates the ceiling drywall without the apparent benefit of a transition housing, double wall, B-vent pipe is required to have 1" clearance to combustible material, drywall is with paper coating is considered a combustible. Sometimes the metal transition housing is covered by drywall compound and not visible, recommend verifying or clearing a one inch space around the vent pipe. Installing a metal cap ring or transitional housing is recommended.

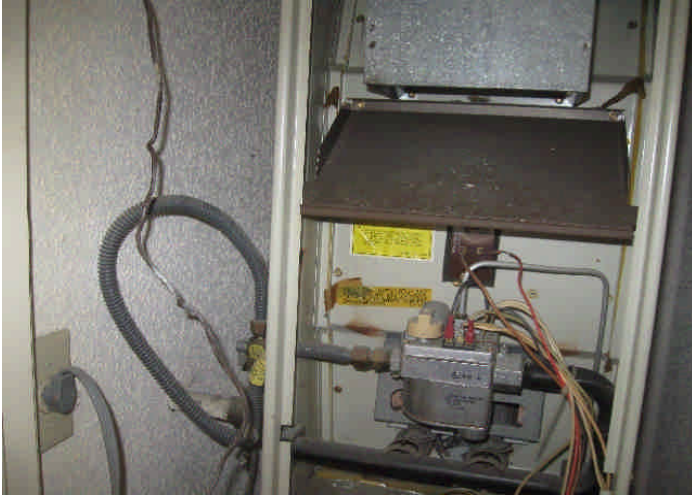
8.3 - ↪ You should be aware that the gas feed line that passes through the furnace sidewall is flexible, and is required by current codes or manufacturer's requirements to be rigid until it passes beyond the furnace, and then flexible to the point where it connects to the gas valve. This can possibly cause vibration or seismic damage to the thin walled flex gas line. This condition is recommended to be corrected by an HVAC contractor or gas appliance specialist.

The gas feed line that passes through the furnace sidewall is flexible and should be rigid - *Continued*

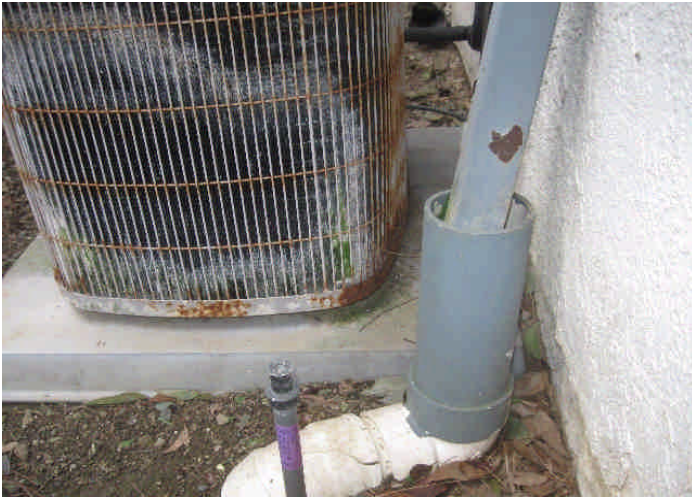
8.5 - → The air conditioning\heating system is cooling, however, it is rusted and the sprinkler next to it appears to be spraying the unit, it is recommended to be serviced to keep the system in peak condition to insure no damage, the sprinklers and drainage directed away from the unit, the AC condenser cleaned, refrigerant level checked and the evaporator verified as having the condensation draining properly and with good air flow through the system. This is especially important when the system is over five years old and will keep the system functioning properly when needed during the warmer times of the year. This is normal maintenance recommended at least every two years with the filters changed every couple of months depending on use of the system.

The air conditioning system is recommended to be serviced to keep the system in peak condition - *Continued*

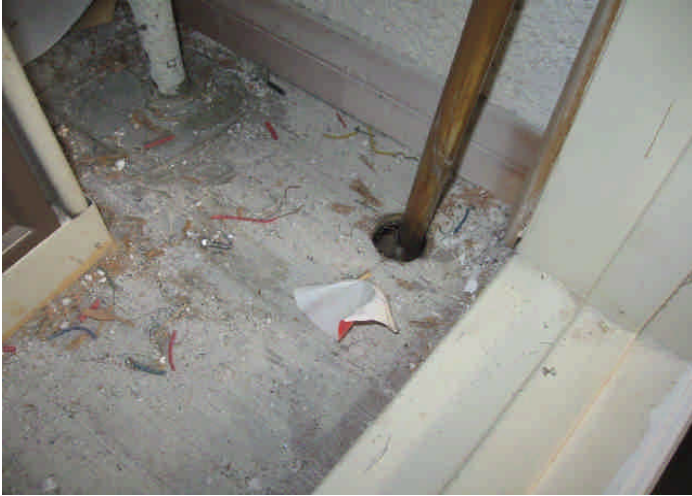
8.8 - ✓ A hole in the bottom of the closet and return air is recommended to be properly sealed.

A hole in the bottom of the closet and return air is recommended to be properly sealed - *Continued*

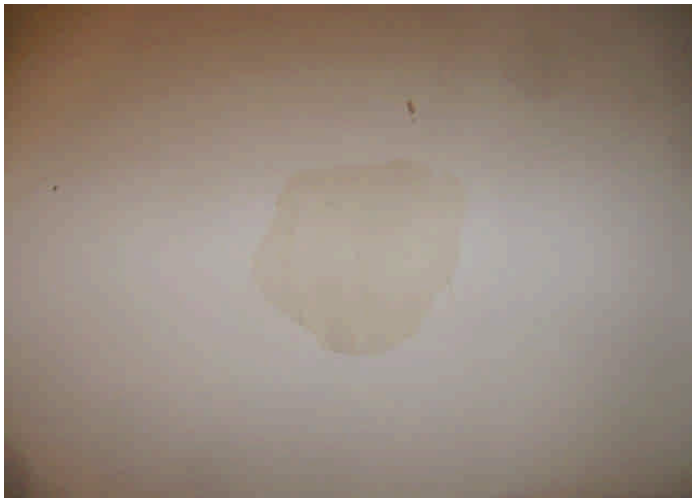
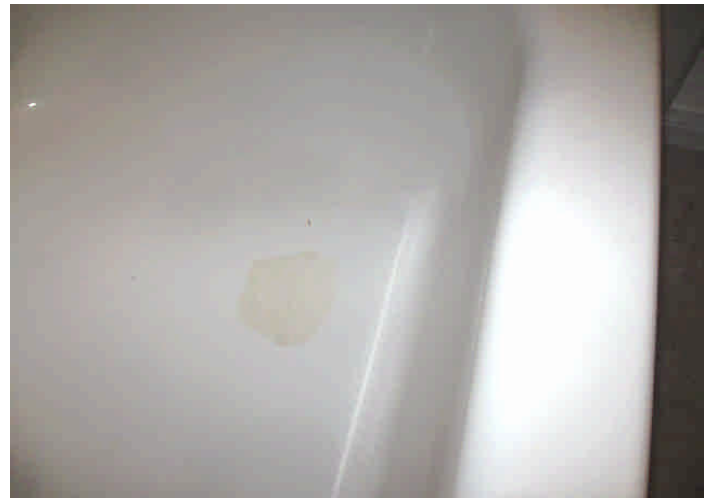
- The epoxy painted tub has paint peel at the bottom of the tub that is recommended to be corrected that will probably require the tub to be re epoxy painted.

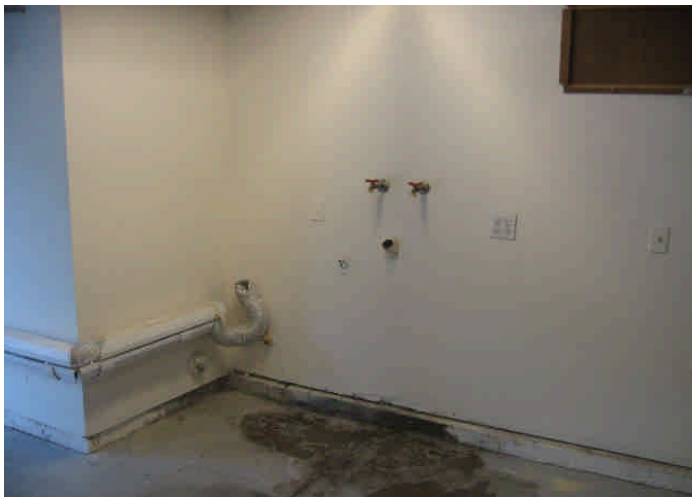
- There is a leak on the cold-water shut-off valve at the washer connections that you want to have repaired before installing the washing machine.

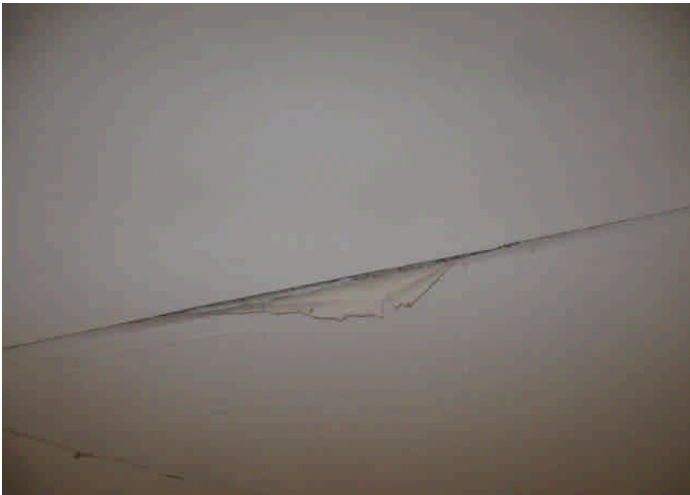
- There are dry moisture stains/damage on the garage ceiling. Recommend further investigation and repairs to correct any leaking or moisture damage.

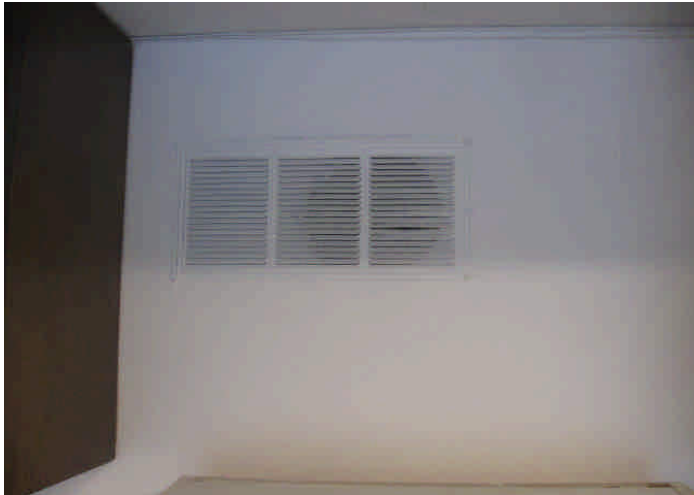
The voids in the garage firewall must be repaired - *Continued*

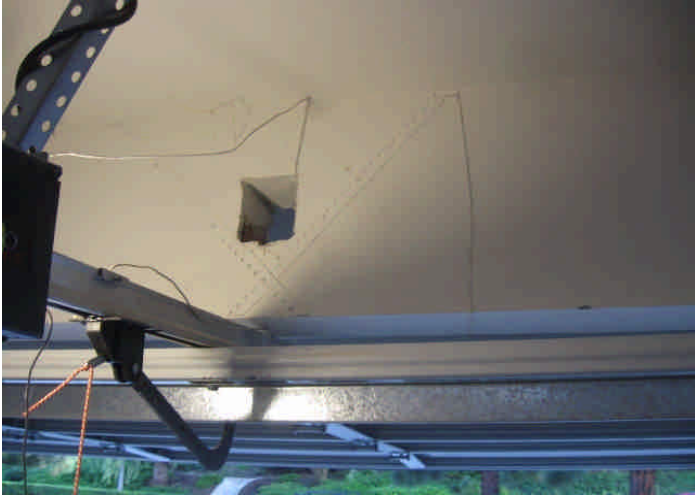
Support beam in the garage has been notched for the garage door operator - *Continued*
