Americas Hometenders

CONFIDENTIAL INSPECTION REPORT

2014 Old Ranch Road, Laguna Niguel, CA

12/23/2009 10:00 am to 1:30 pm

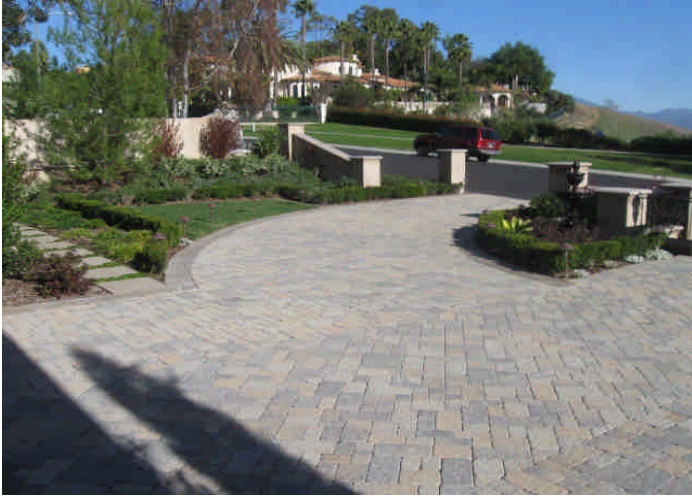
- The paver driveway did not have any unusual displacement or cracks.

The driveway is in acceptable condition - *Continued*

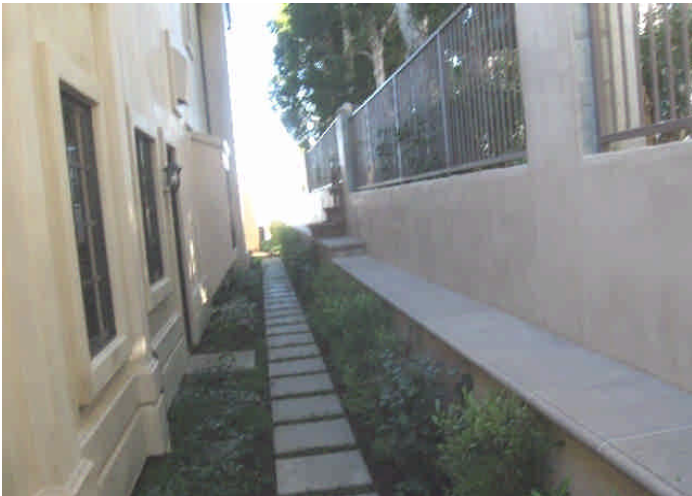
- Yard-retaining walls did not have any unusual damage or cracking.

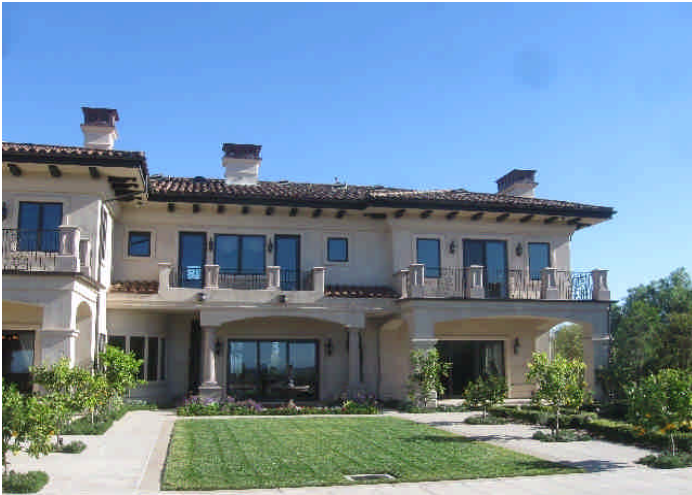
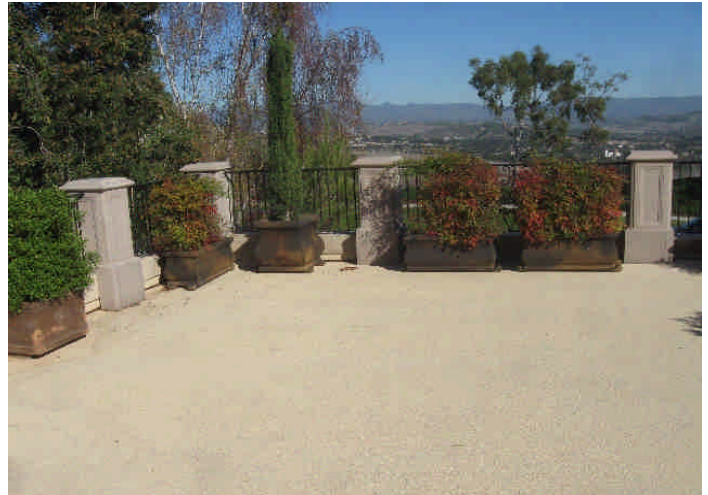
- Water proofed coated and tiled decks had no apparent damage and the drainage was away from the structure, recommend sealing of surface on a regular basis to prevent deck surface deterioration.

Water proofed coated deck had no apparent damage-recommend sealing of surface to prevent deterioration - *Continued*

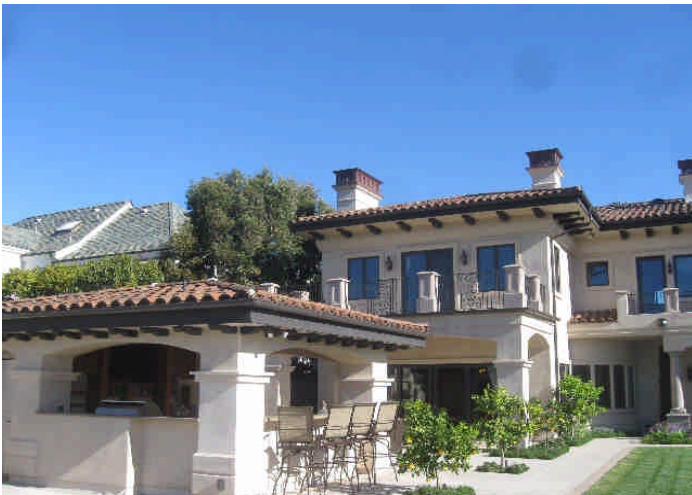
- Patio masonry pad does not appear to have any unusual displacement or cracking, it appears to drain away from the foundation, this should be verified during heavy rains.

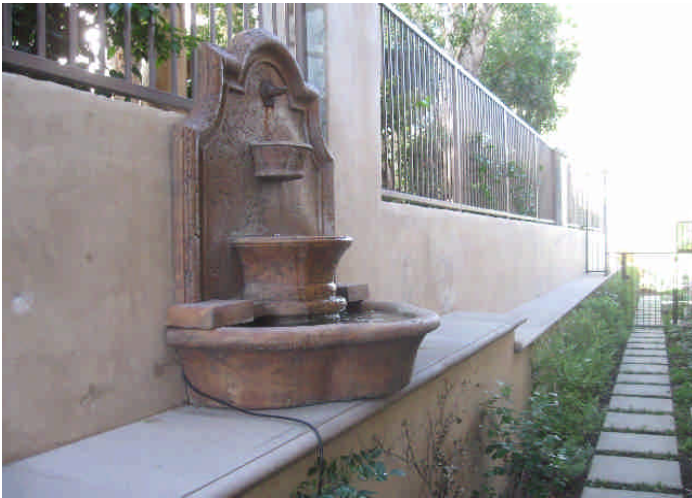
- A concrete wall fountain was working and has GFCI protection for the fountain pump.

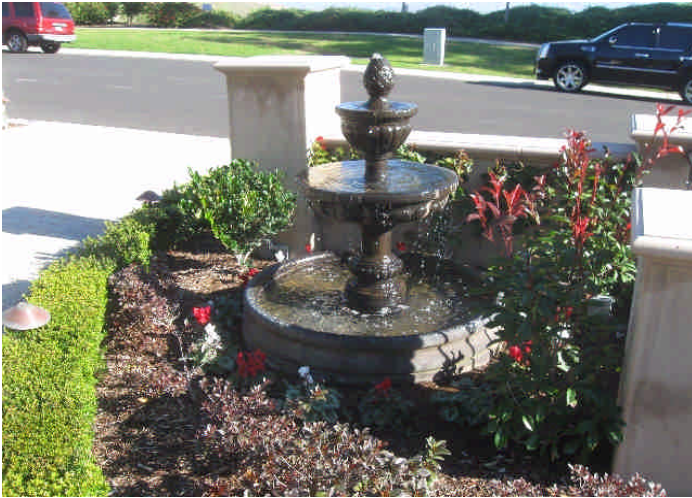
- Water fountains are recommended to be monitored for child safety-verified as being properly secured against tip over if a child climbs on them. Fountains were GFCI protected.

Water fountain is recommended to be monitored for child safety-verified for GFCI protection - *Continued*

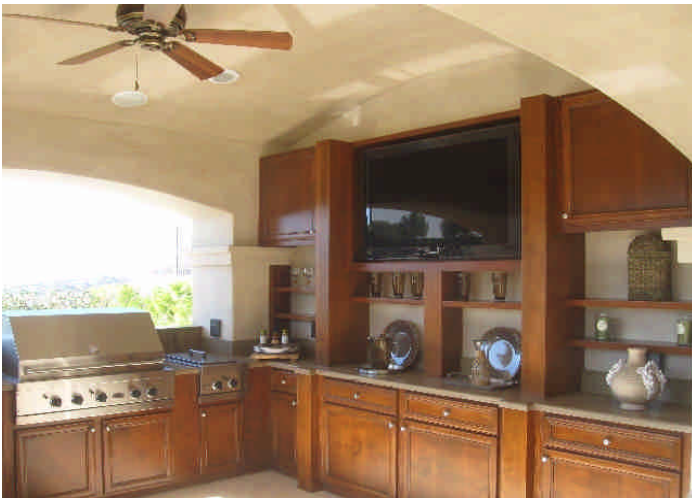
- Barbecue was located in the back yard-patio pool house area. The gas valve was on and there was gas to the barbecue, igniters were working.

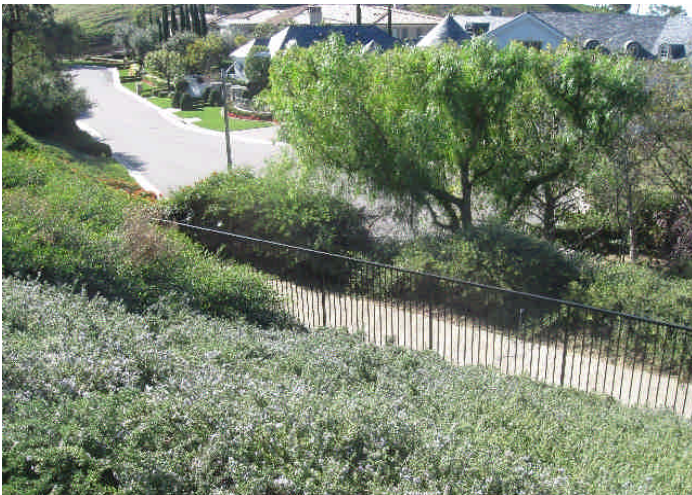
- The property is located on a hillside or stair stepped location with no evidence found of unusual movement from soils or drainage. The property has in ground drains and/or gutters. However, due to the location on the hillside it is encouraged that you investigate to insure soils engineering or a geo tech engineer has evaluated the property for proper drainage, proper hillside maintenance and potential soils movement.

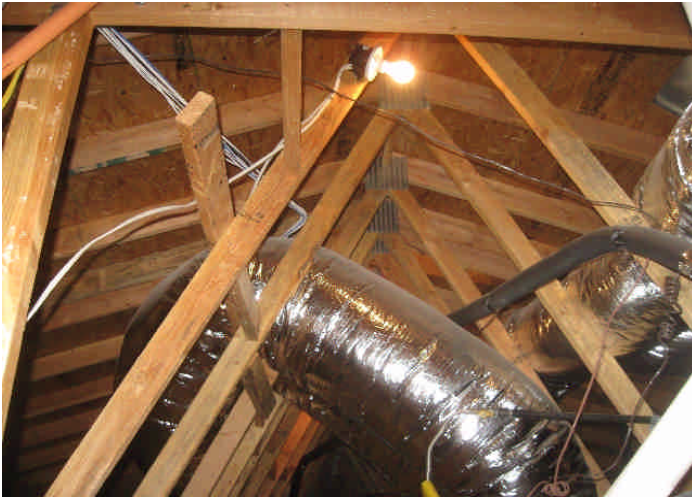
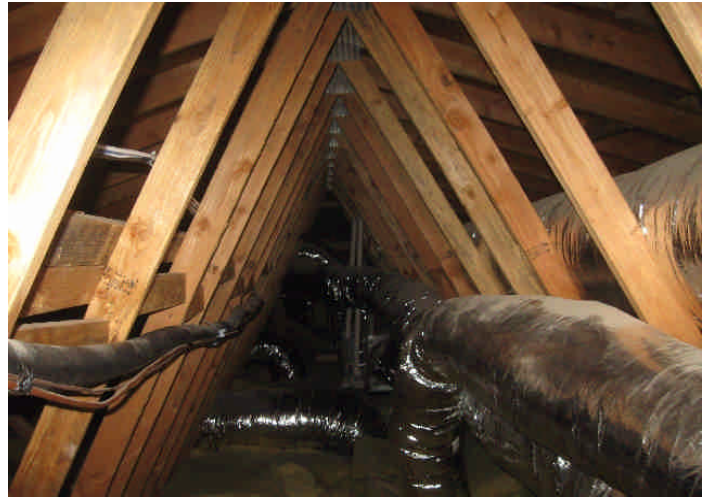
- The roof framing consists of a factory- built truss system, comprised of components called chords, webs, and struts that are connected by wood or metal gussets nailed or glued in place. Each component of the truss is designed for a specific purpose, and cannot be removed or modified without compromising the integrity of the entire strut. The lowest component, which is called the chord and to which the ceiling is attached, can move by thermal expansion and contraction and cause creaking sounds, which are more pronounced in the mornings and evenings along with temperature changes. Such movement has no structural significance, but can result in small cracks or divots in the drywall or plaster. No unusual movement or damage was found on the visible portions of the truss system at time of the inspection.

The roof framing consists of a factory-built truss system - *Continued*

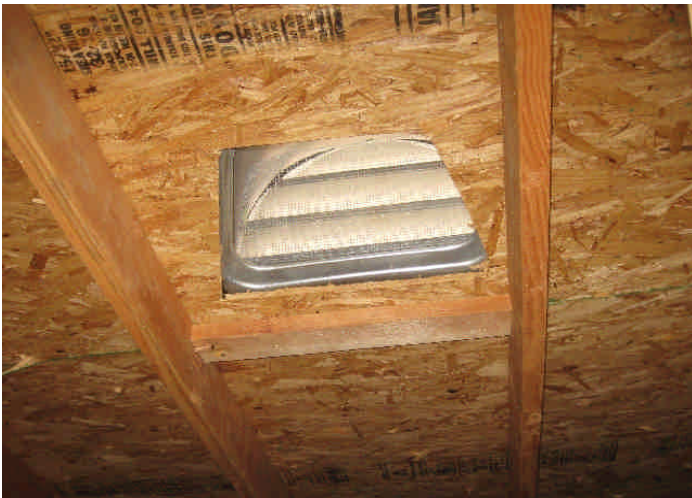
- Ventilation within the attic is provided by a combination of eave, dormer, turbine, or gable vents, and should be adequate.

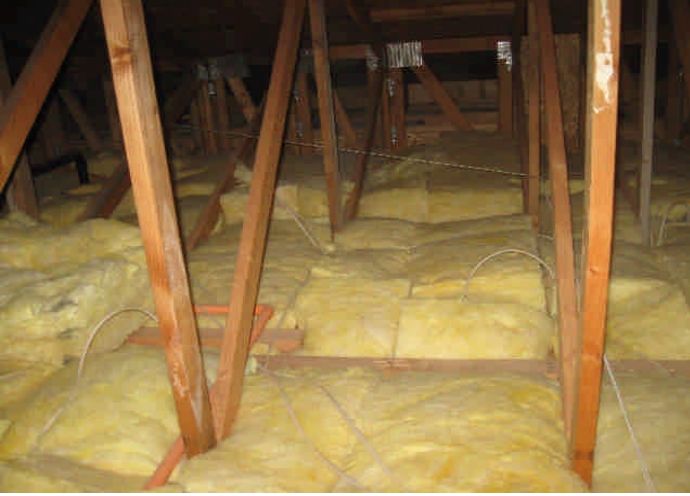
- The attic floor is well insulated with approximately nine-inches of fiberglass, batt insulation.

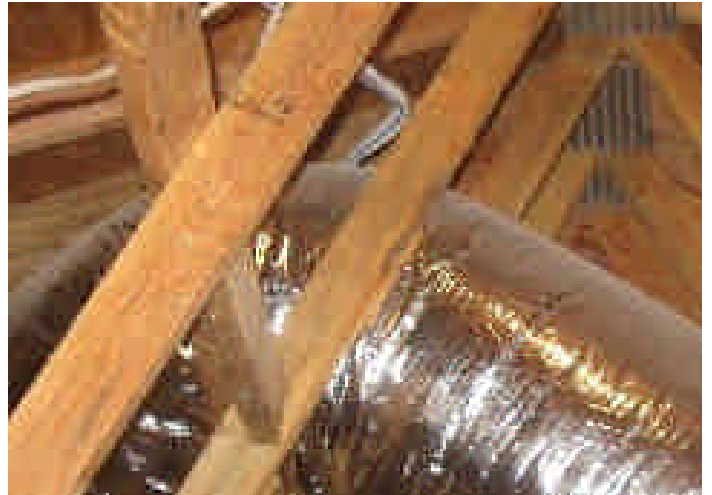
- The visible heating-cooling ducts in the attic did not appear to have any damage at time of the inspection.

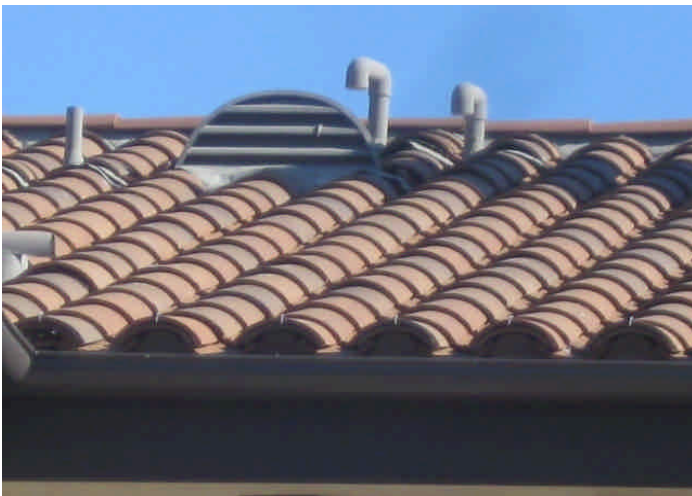
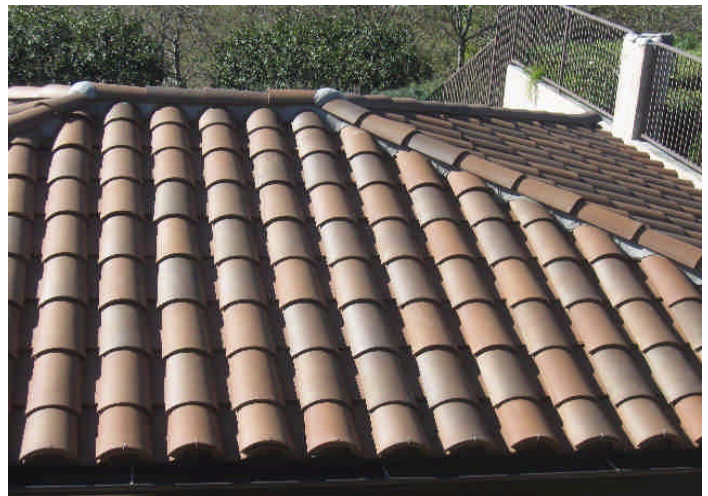
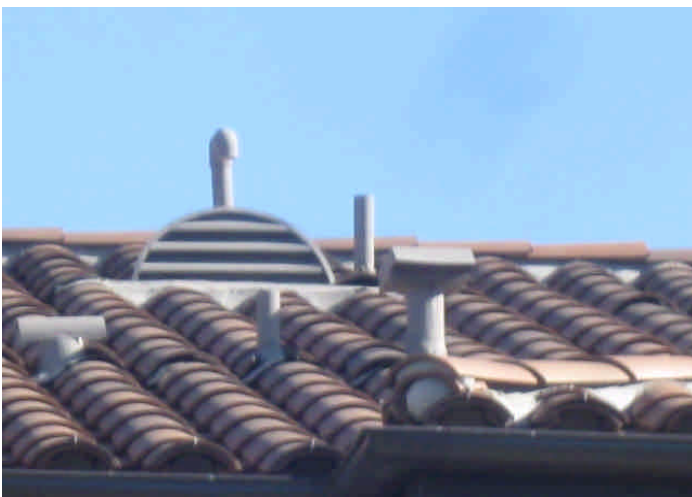
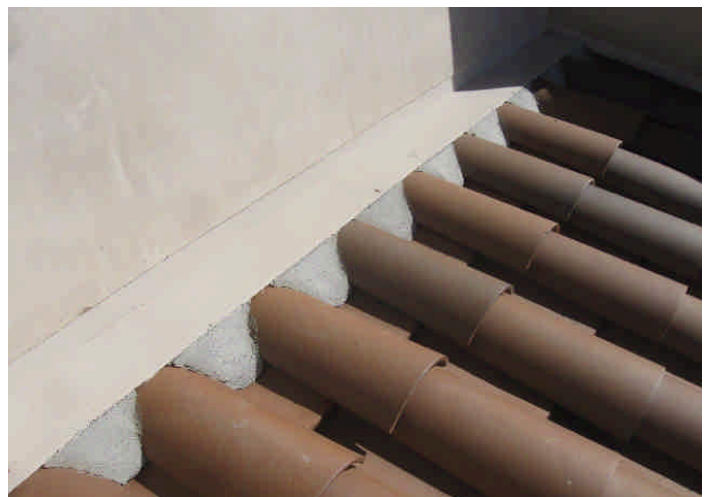
- The clay tile roof appears to be the same age as the home and is around one year old without any evidence of leaking found at the ceilings or attic. To avoid damaging the tiles, we elected not to walk on the roof, and inspected it instead from within the attic and from a variety of other vantage points using a ladder. The areas viewed appeared to be in acceptable condition, however, not all the roof was viewed, and this is not a guarantee against leaks.

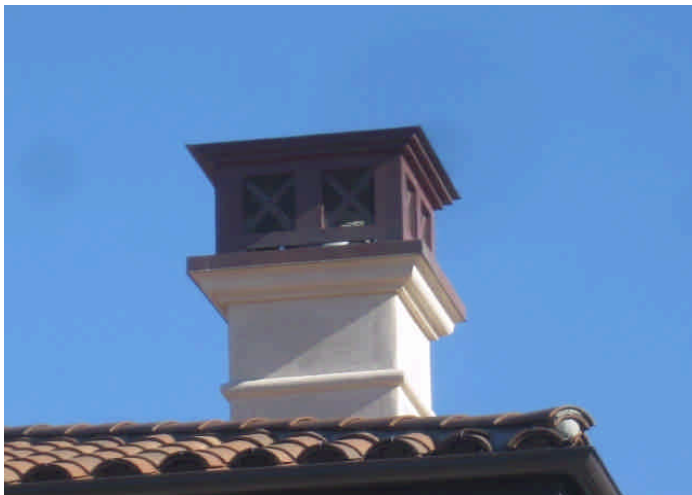
- A spark arrestor housing is in place on the chimney.

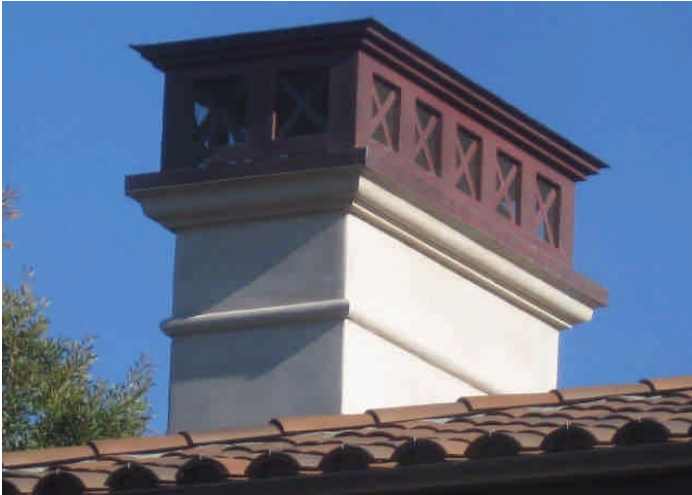
- A functional spark arrestor is in place on the chimney.

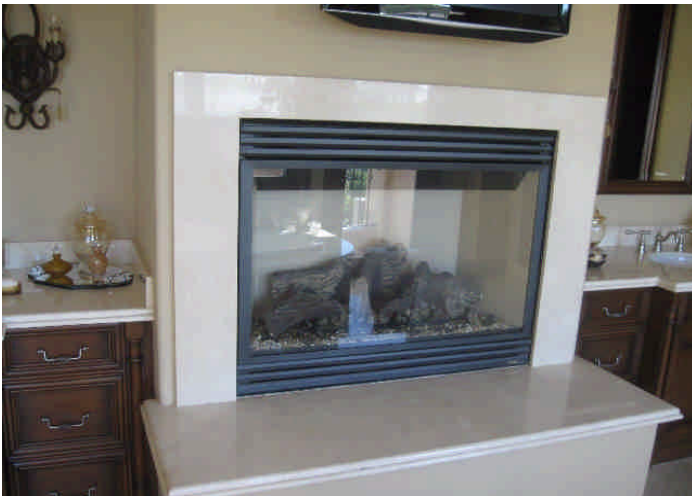
- The fireplace did not appear to have any unusual displacement or damage, clearance to combustibles appeared adequate on visible portions of the fireplace, the hearth was in place.

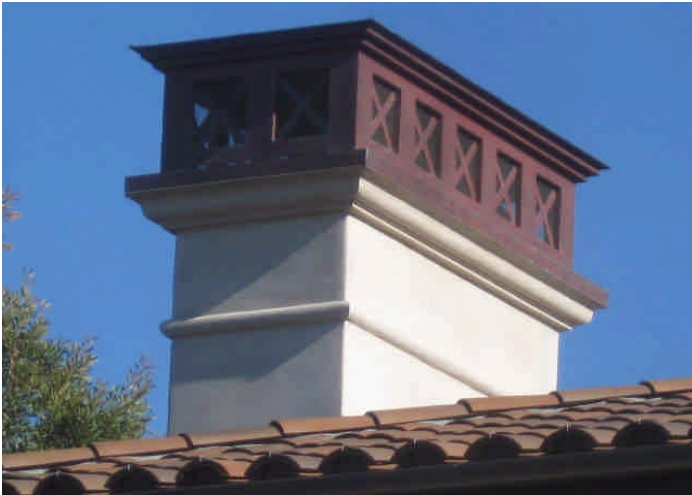
- A spark arrestor is in place on the chimney.

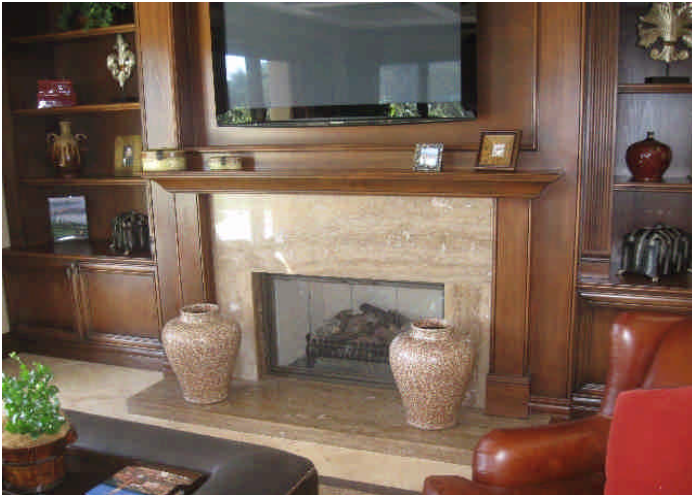
- The fireplace did not appear to have any unusual cracking or damage, the clearance to combustibles appeared to be appropriate.

The fireplace is in acceptable condition - *Continued*

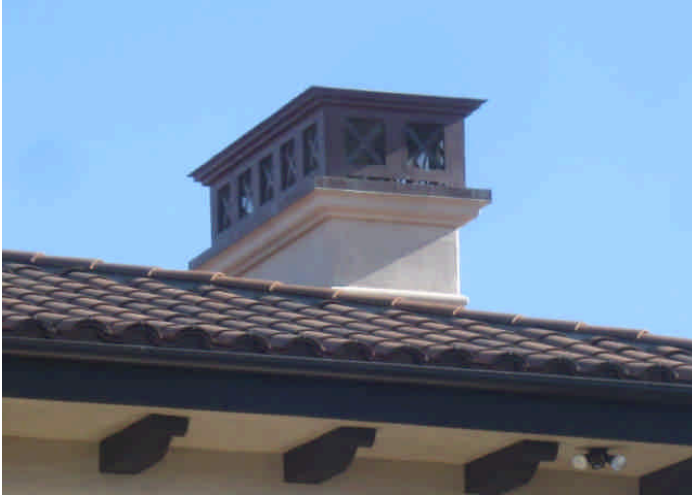
The weather cap on the chimney is in acceptable condition - *Continued*

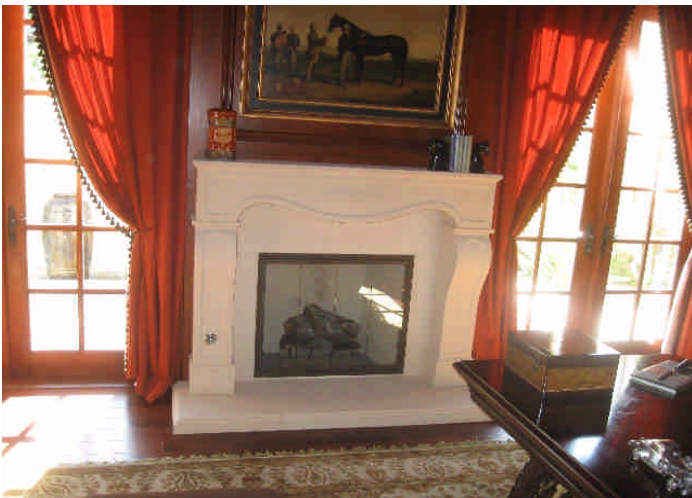
- The fireplace did not appear to have any unusual damage or displacement.

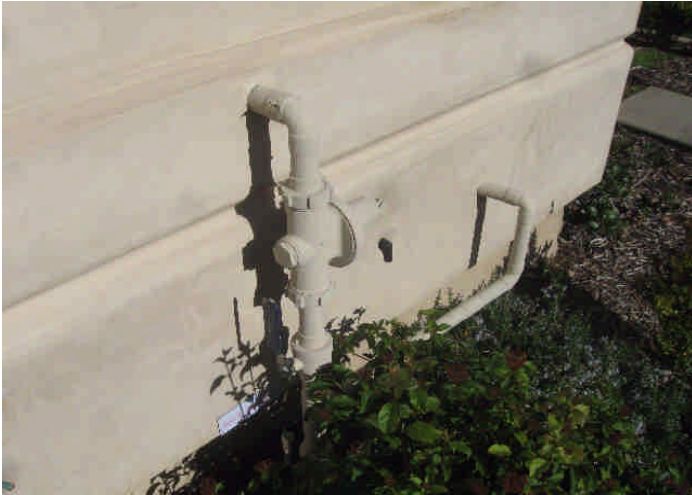
- Water main shut off is a newer style ball valve.
- Water pressure is within normal operating range between 40 and 80 psi.
- The main water shut-off valve is located in the side yard.

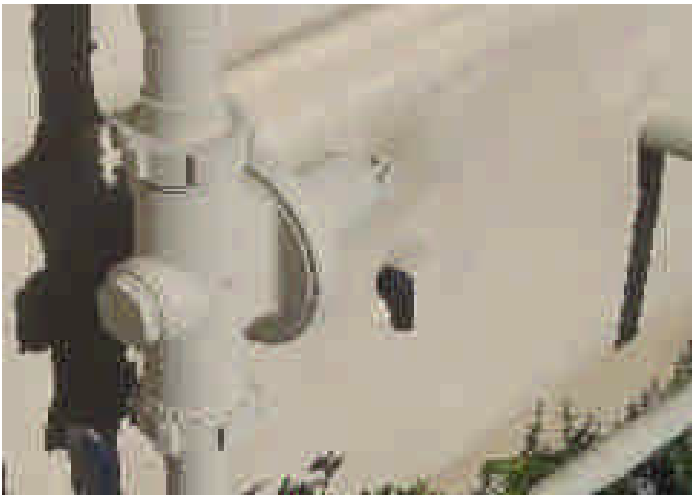
- An adjustable water pressure regulator is in place on the plumbing system. Pressure regulators can normally be adjusted by turning the bolt clockwise for increasing the pressure and counter clockwise for decreasing the pressure, recommend not adjusting the pressure over 80 psi.

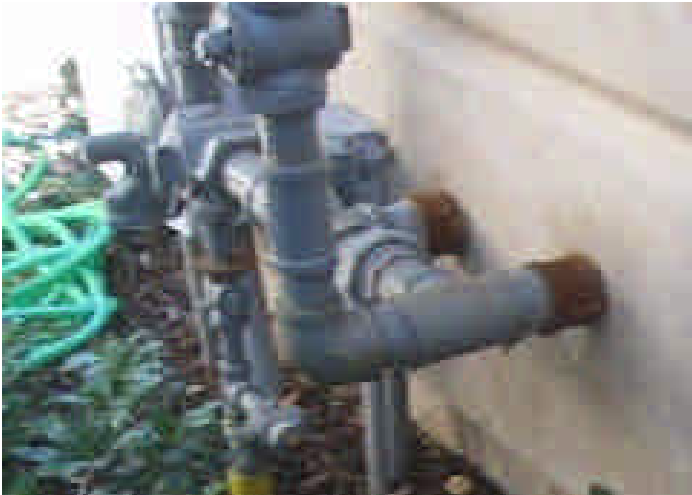
Recommend the gas shut off valve have a wrench attached or a seismic auto shut off valve installed - *Continued*

5.1 - ↪ Recommend the gas shut off valve have a wrench located at the shut off valve or a seismic auto shut off valve installed in case of emergency. Some insurance companies are now requiring that an automatic gas shut off gas valve be installed before they will insure you, this should be verified with your insurance company. They cost around \$350 to install. Some City construction jurisdictions require the auto shut off valves when a property is sold, verify with your City or insurance company on requirements before close of escrow. If the wrench only is used, it is recommended that the Gas Company's gas meter valve be verified as easily operated.

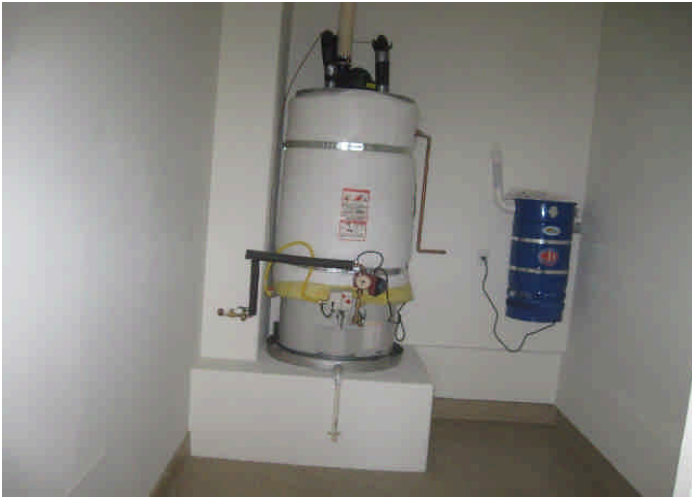
The water heater is seismically secured - *Continued*

- Water heater has seismic straps in place, however, the straps do not wrap around the water heater which is not always required by the manufacturer's installation requirements, however, it is recommended that this upgrade be performed to prevent possible swinging of the water heater during seismic activity that could break a water line, or gas line.
- 75 gallon water heaters are recommended be upgraded to have three approved seismic straps installed for extra holding support on the larger water heaters, or verifying that the two straps are rated to support a 75 gallon water heater as now required by the State of California Architects Office.

5.3 - ↪ Water heater has seismic straps in place, however, the straps do not wrap around the water heater which is not always required by the manufacturer's installation requirements, however, it is recommended that this upgrade be performed to prevent possible swinging of the water heater during seismic activity that could break a water line, or gas line.

5.4 - ↪ 75 gallon water heaters are recommended be upgraded to have three approved seismic straps installed for extra holding support on the larger water heaters, or verifying that the two straps are rated to support a 75 gallon water heater as now required by the State of California Architects Office.

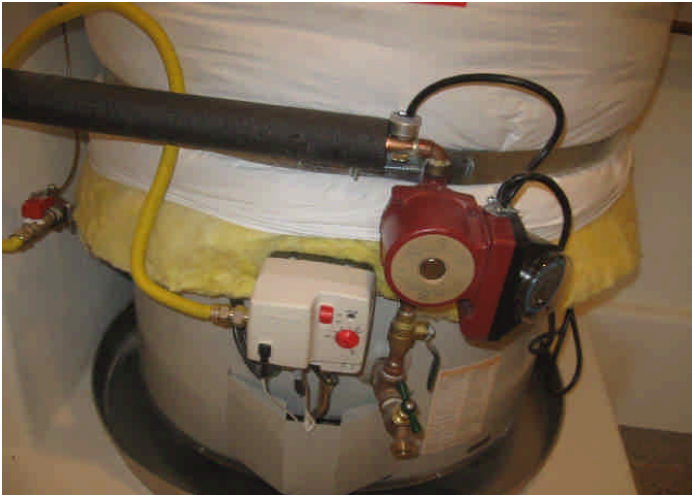
Water heater has a recirculating pump installed to deliver the hot water quickly to the faucets - *Continued*

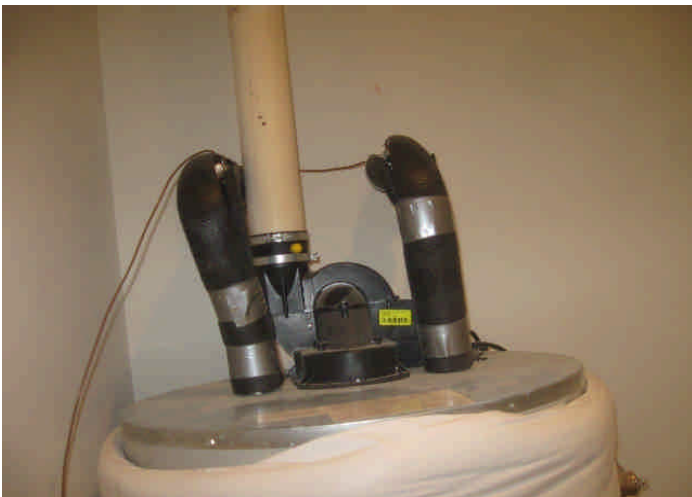
- The shut-off valve and water connectors on the gas water heaters do not appear to be leaking and have no apparent damage other than some minor corrosion. The valve is not tested due to the potential for leaking at the valve.

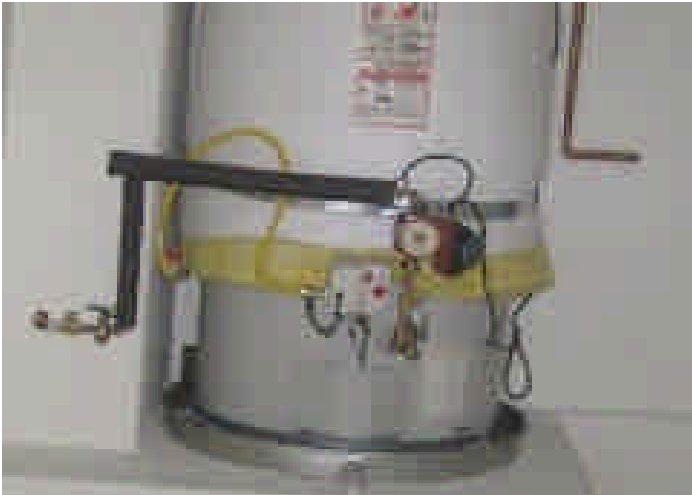
The gas control valve and its connector at the water heater are functional - *Continued*

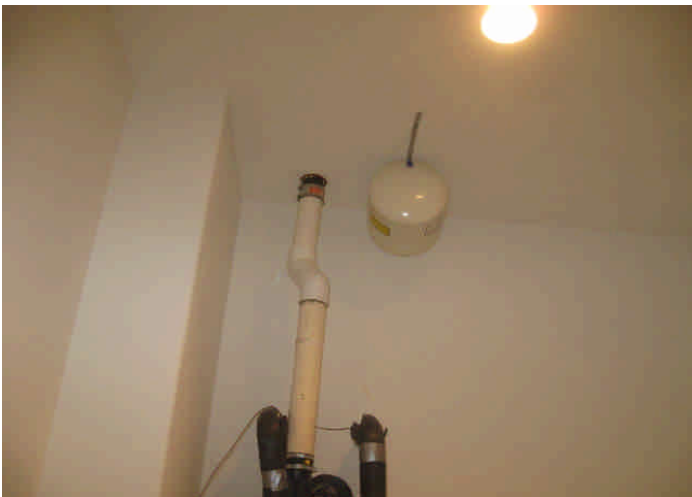
- Expansion tank has been installed on the system. This small tank is usually installed at the ceiling close to the water heater and has an air bladder in the tank that allows for expansion of the water as it heats in the water heater and also helps prevent water pipe slam when turning a fast flowing water faucet off quickly.

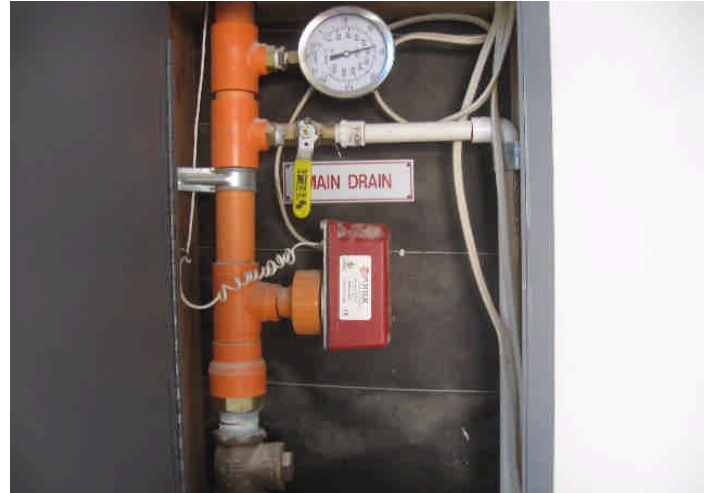
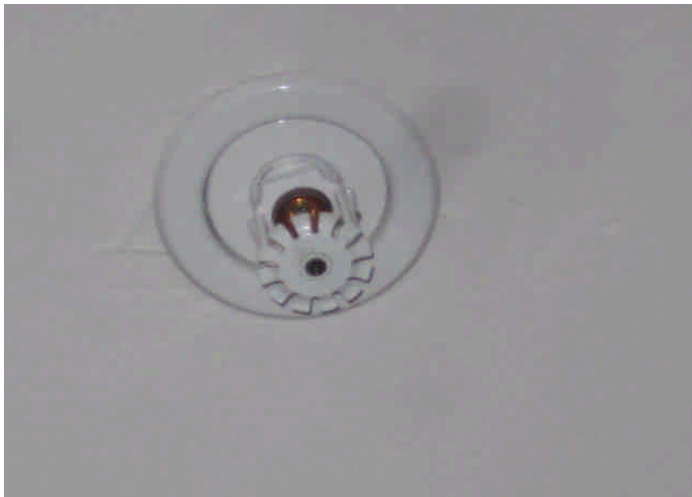
- The structure is equipped with fire sprinklers/alarm system, which are not part of this inspection. The fire sprinkler system is recommended to be evaluated by a fire sprinkler specialist and certified as being functional and should be tested on a regular basis. Regular servicing with valve testing and verification that the sprinkler heads are not on recall, recommended to be done at least every five years or at point of sale of the property. Recommend getting the servicing information from the seller if it has been recently serviced by a fire sprinkler system specialist or it is recommended to be done. (no evidence of leaking around any of the sprinkler heads or pipes was found at time of the inspection)

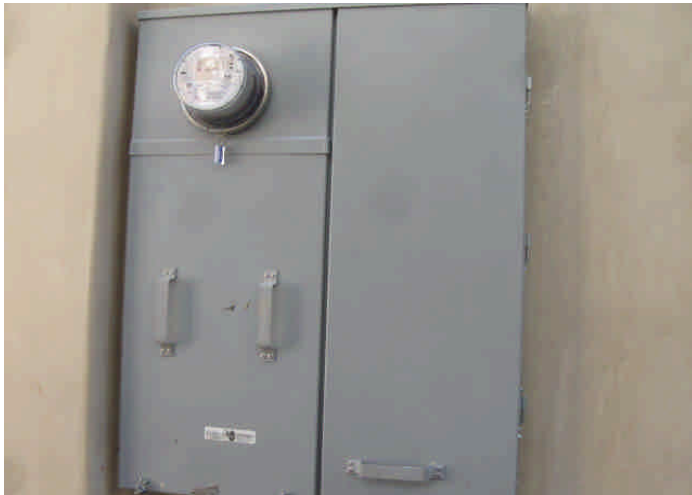
- The residence is served by 400 amp rated panel, with a 200 amp main breaker and two 125 sub panels, all 120/240 volt panels.

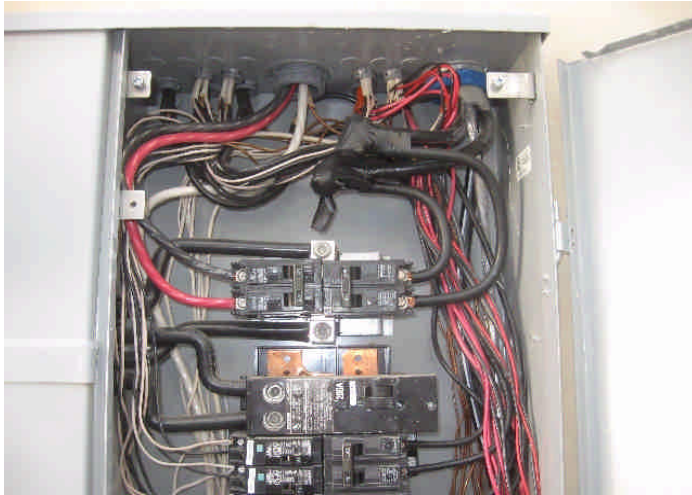
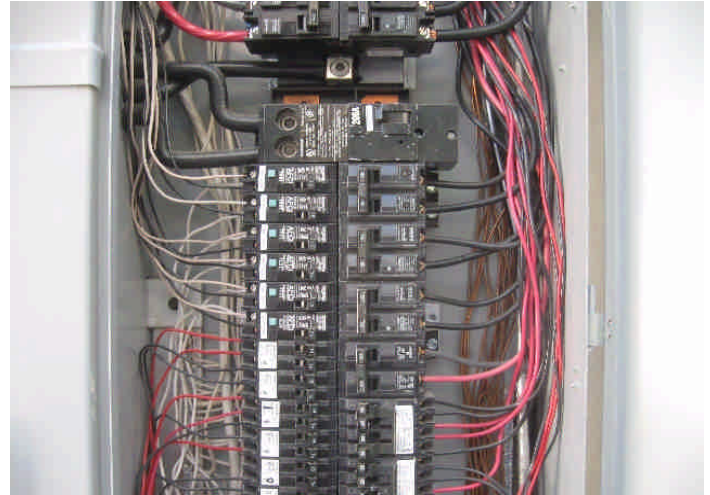
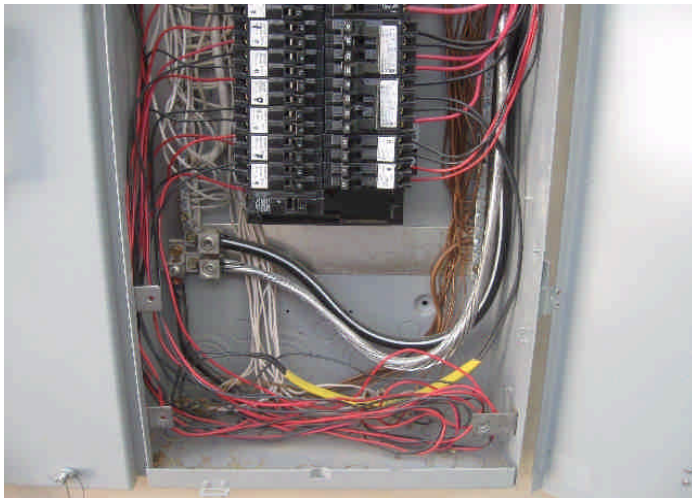
- There is no visible damage to the circuit breakers or wires in the main electrical panel.

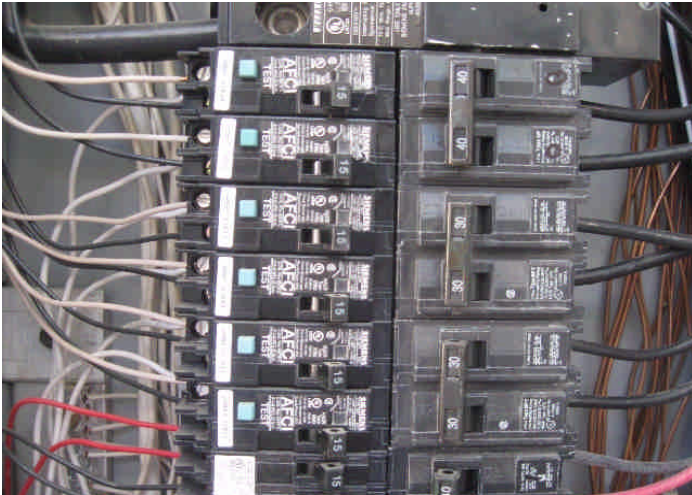
- AFCI bedroom breakers to prevent arcing are in place in the main panel. These are to prevent arcing at electric outlets and plug in items in the bedrooms that might cause arcing/spark fires. If no power in the bedroom electric outlets, it is recommended that you check for any sources of electric sparks in the bedroom and reset the AFCI breaker in the electric panel.

AFCI bedroom breakers to prevent arcing are in place in the main panel - *Continued*

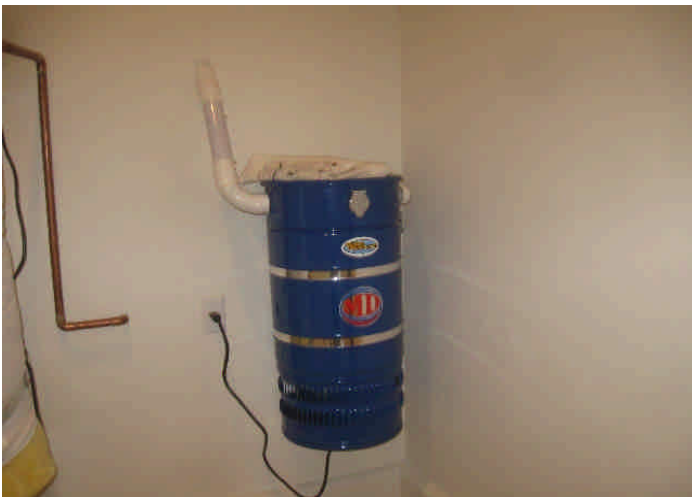
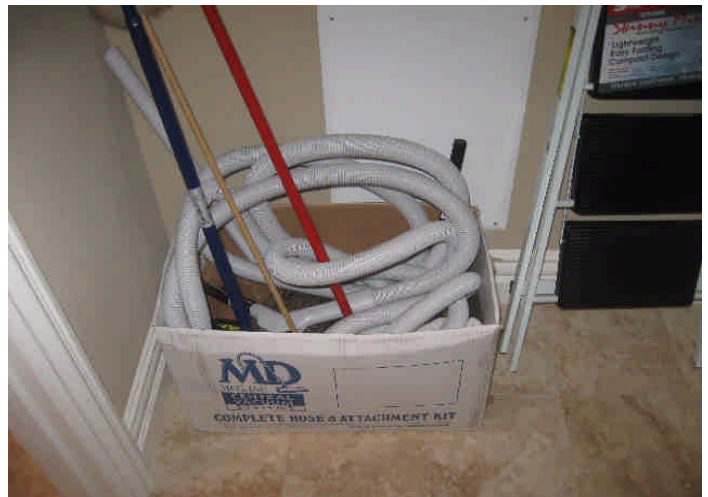
- A central vacuum system is in place, however, is not part of this inspection and should be demonstrated by the sellers before the close of escrow. (hose in elevator closet was tested on a few of the vacuum wall outlets and were working)

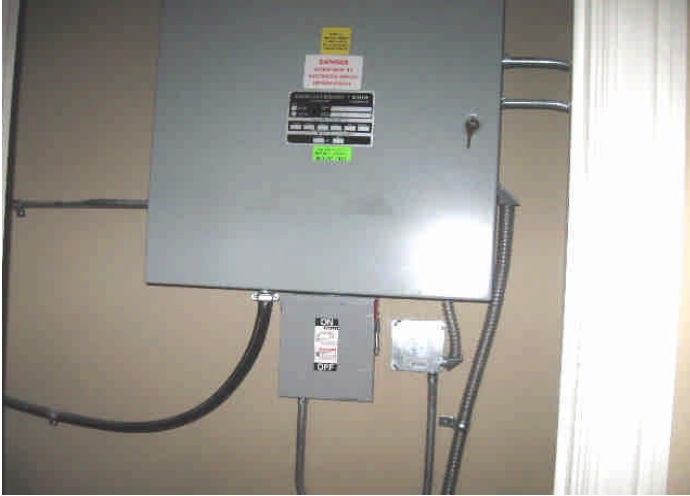
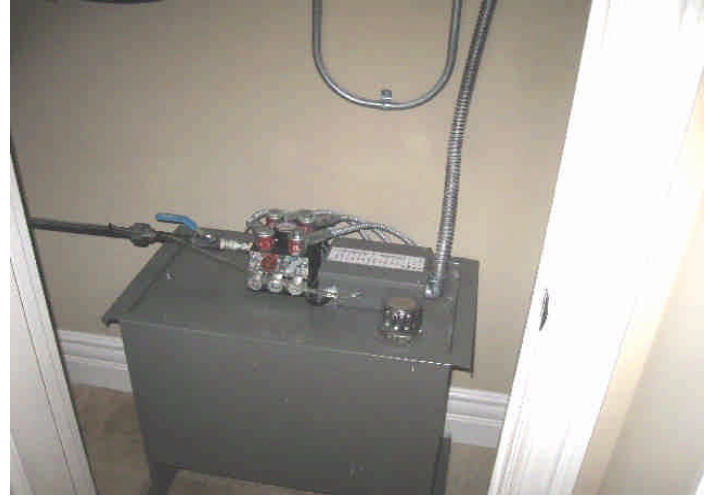
- An elevator system has been installed in the home and is not part of this inspection and is recommended to be regularly serviced and inspected by a qualified elevator specialist. Recommend further investigation by a qualified specialist. (elevator did respond between floors when buttons were pushed)

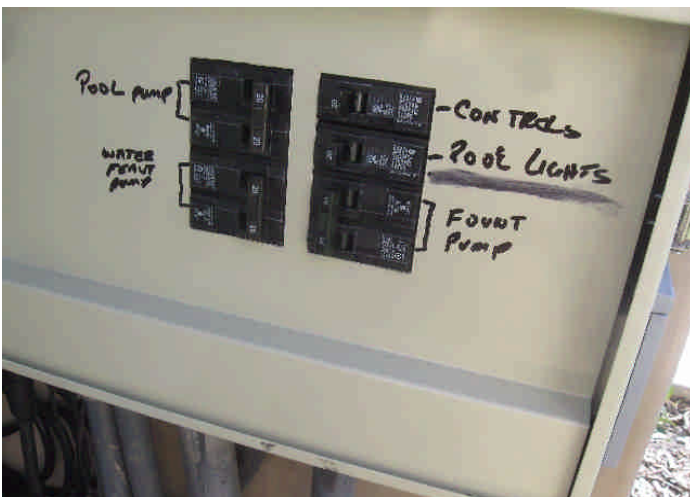
- The residence is served by a 120/240 volt sub panel, located in the pool equipments control panel. No defects or damage was found.

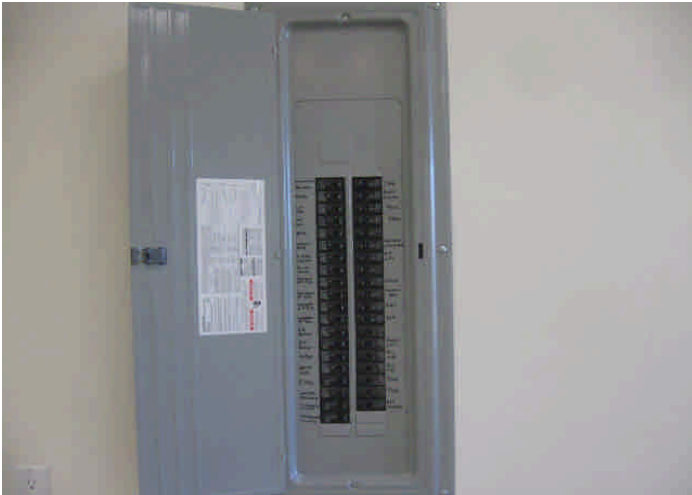
- The sub panel is located inside the garage.

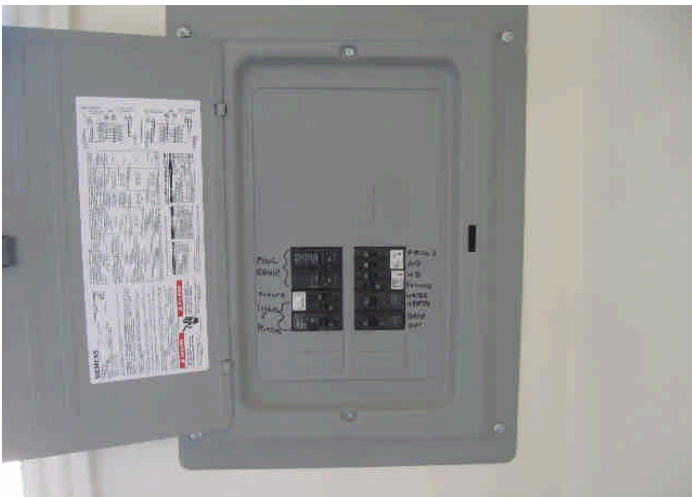
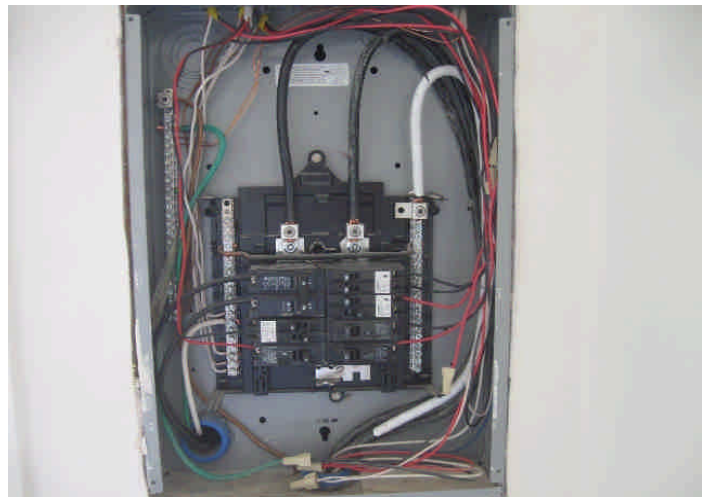
- The pool house has a sub panel located in the closet. No damage or defects were found.

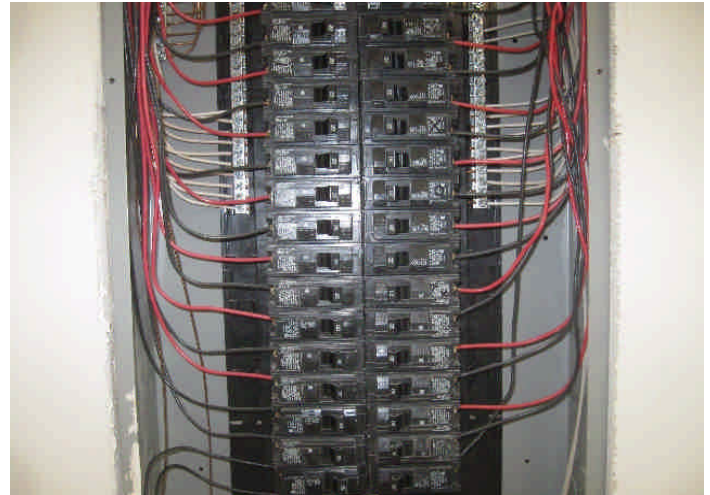
The electrical sub panel has no visible deficiencies - *Continued*

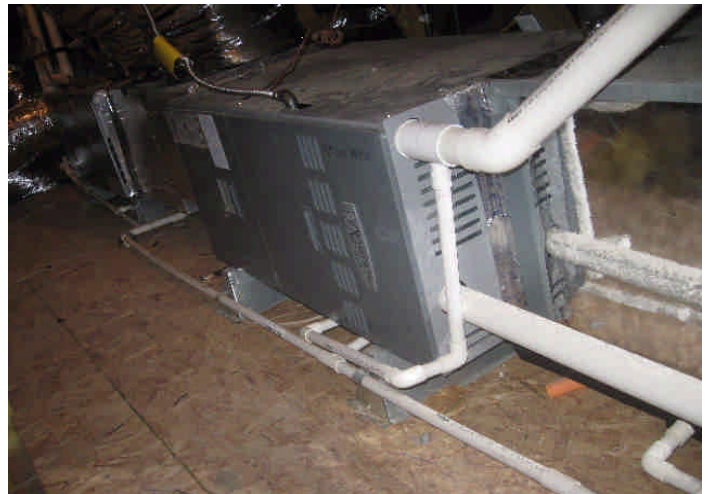
- The furnace turned on and off on demand at the time of the inspection and was producing heat at the registers.

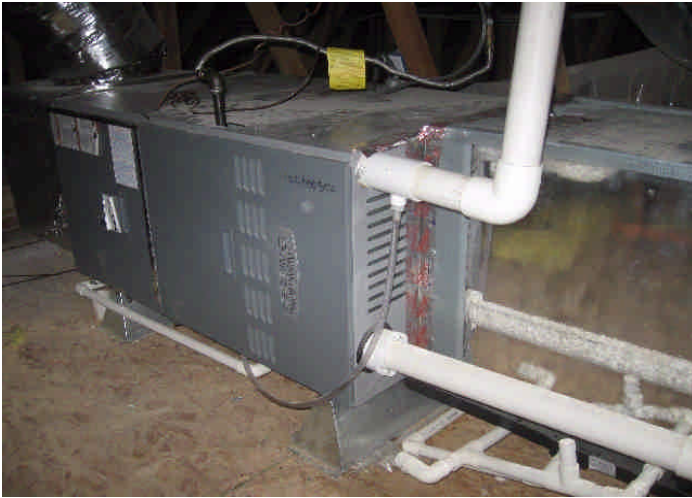
The furnace was producing heat - *Continued*

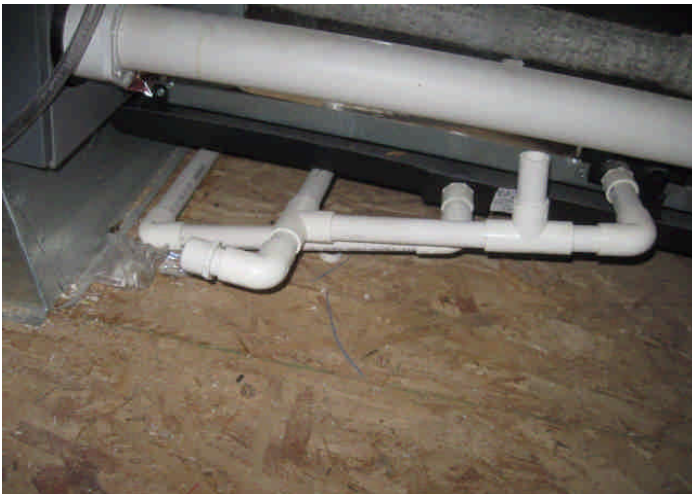
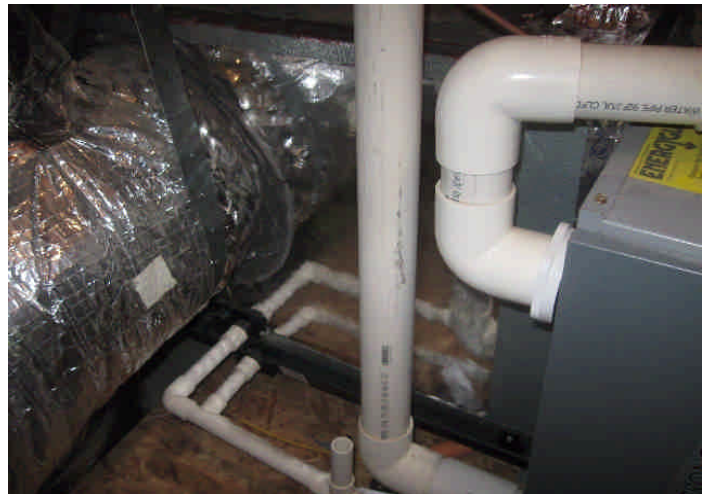
- The drip pan for the AC evaporator unit with drain pipe is in place, no evidence of leaking found at time of inspection. (all three)

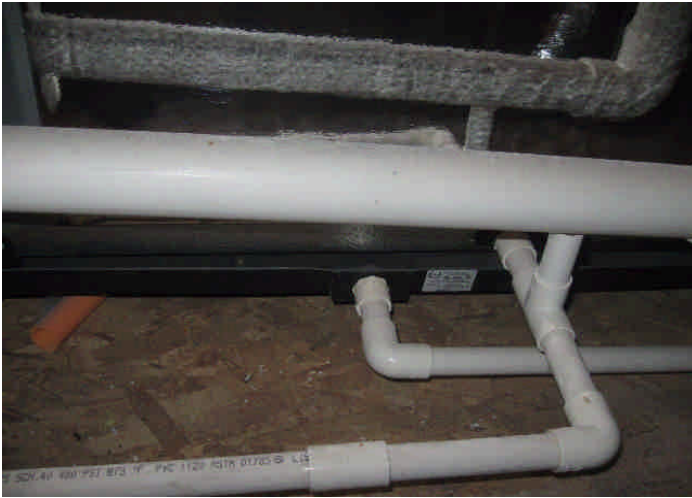
The drip pan is functional - *Continued*

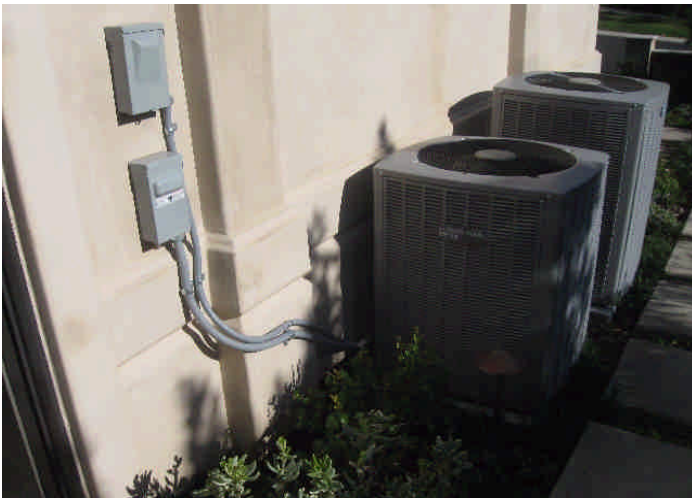
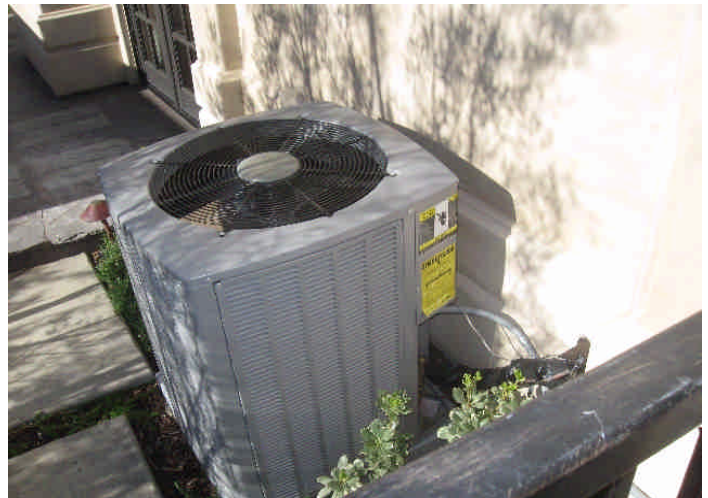
- The AC condensing coil responded to the thermostat and is functional. 14 to 16 degrees temperature differential. All three.

- Recommend strapping the AC condenser to the base pad to prevent accidental movement that might damage the refrigerant or electrical power lines.

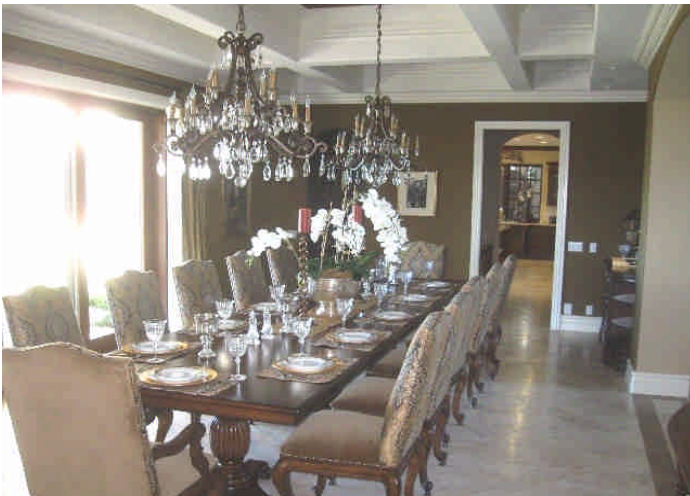
- The floor is tiled and has no significant defects.

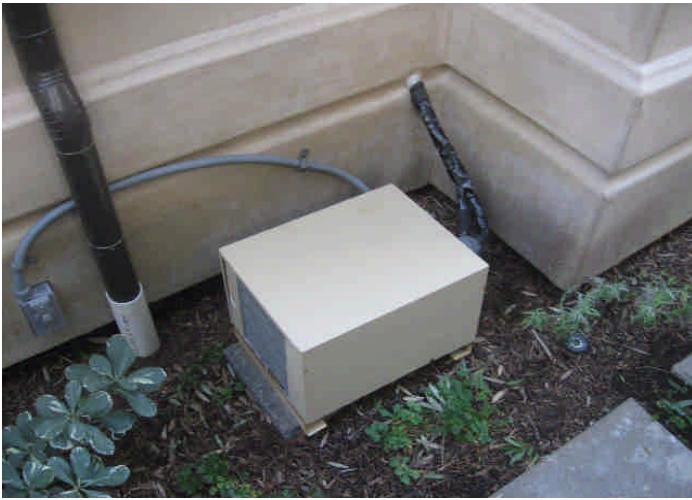
9.1 - → Wine refrigerated closet was in place in the dining room, however, these units are not part of our inspection service and we recommend you get service information from the seller. (refrigeration unit was not on and is recommended to be demonstrated as functional at final walk through)(refrigeration unit condenser located on right side of home)

Wine refrigerated closet was in place - *Continued*
