Americas Hometenders

CONFIDENTIAL INSPECTION REPORT

2014 Old Ranch Road, Laguna Niguel, CA

12/23/2009 10:00 am to 1:30 pm

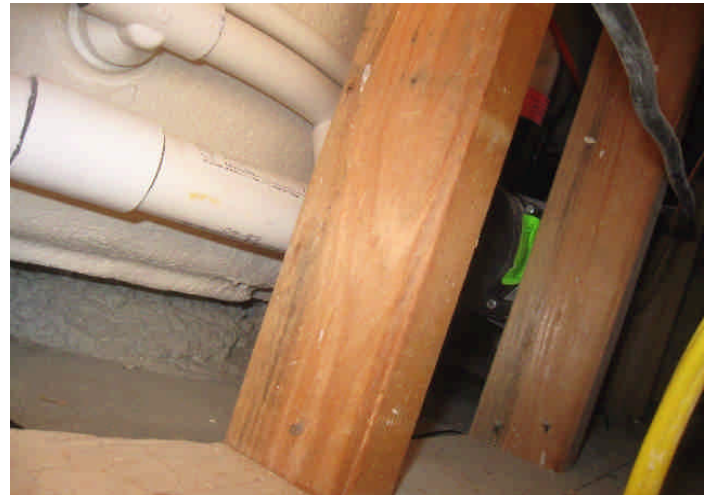
- The spa tub/shower was filled and turned on to verify the motor/pump was functioning which responded to the switch, the GFCI protection and bond wire for the pump were found in the exterior access.

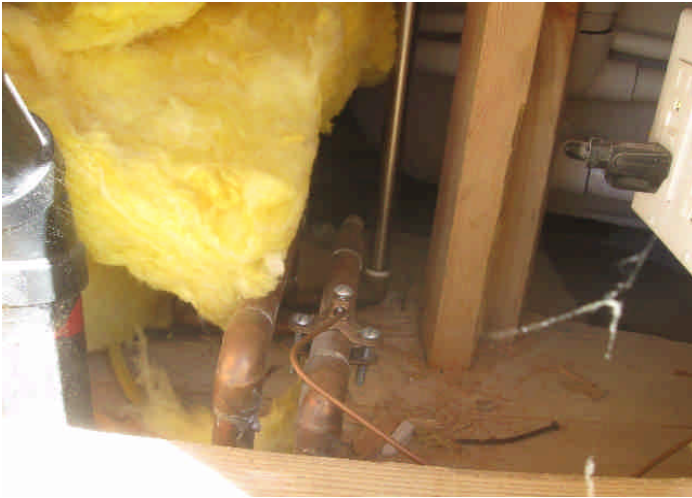
The hydro-spa is functional - *Continued*

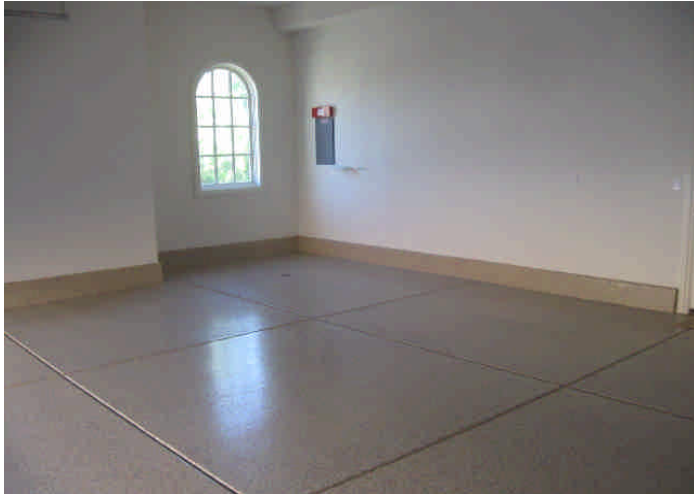
- The visible portion of the garage slab was in acceptable condition. Epoxy painted floors on both garages in good condition.

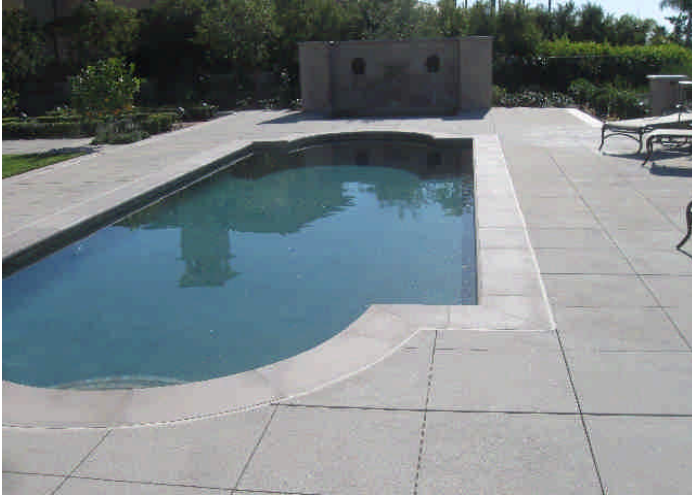
The interior finish of the pool and spa is Pebble-tec and in good condition - *Continued*

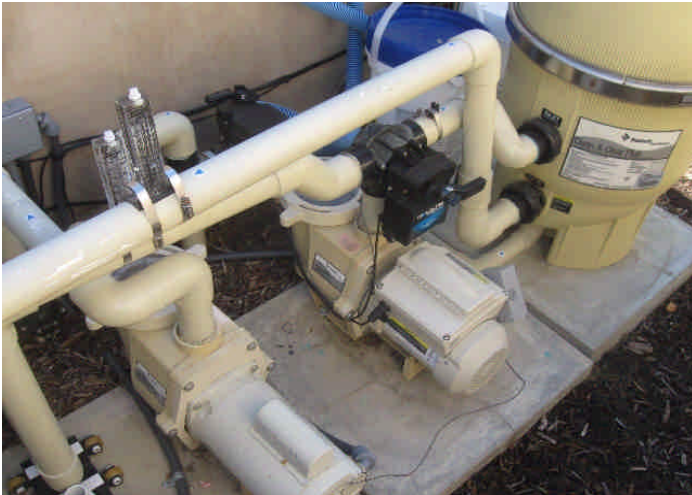
The pool-spa motor is providing good water flow - *Continued*

- The pool-spa motor-pump responded to the switch and is working, recommend getting seller or seller's pool service to demonstrate the proper settings on the equipment valves for turning on the spa jets and varying the controls on the equipment for spa jets, pool sweep and circulation.

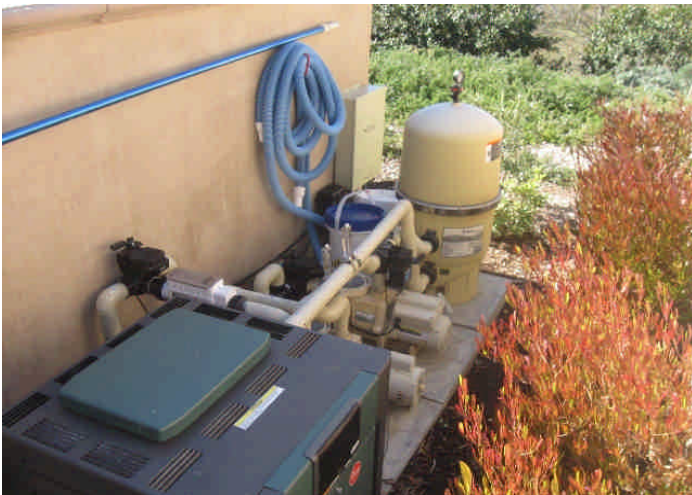
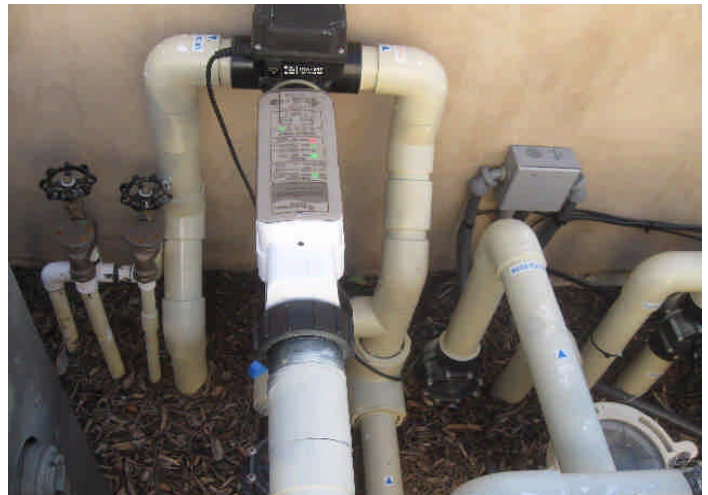
- The visible portions of the supply and return lines and their valves did not appear to have any leaking.

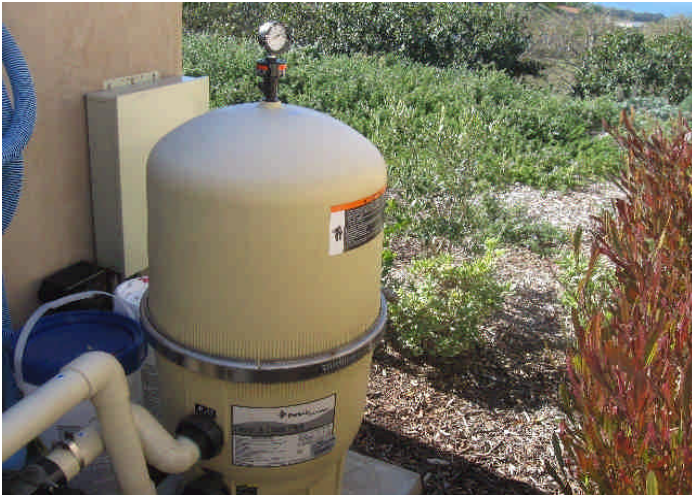
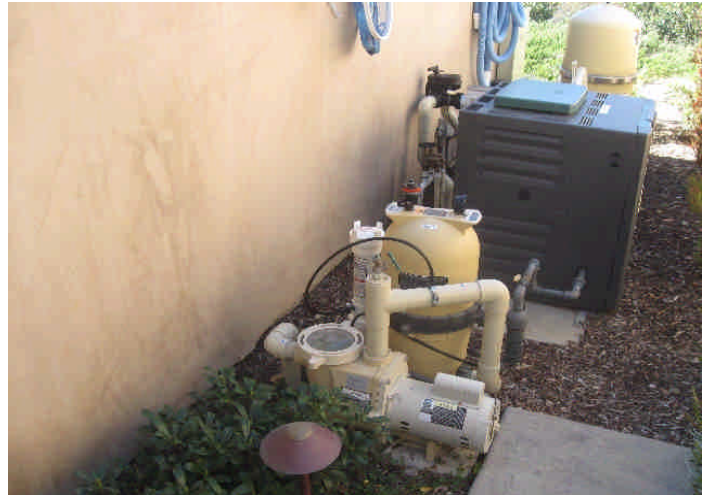
The filter is a cartridge type which appears to be functioning properly - *Continued*

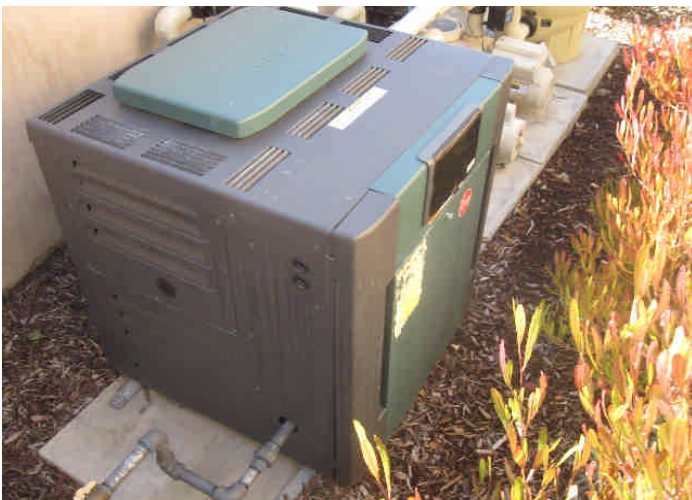
- The pool or spa heater responded to the controls and was heating water, but should be kept clean and serviced seasonally.

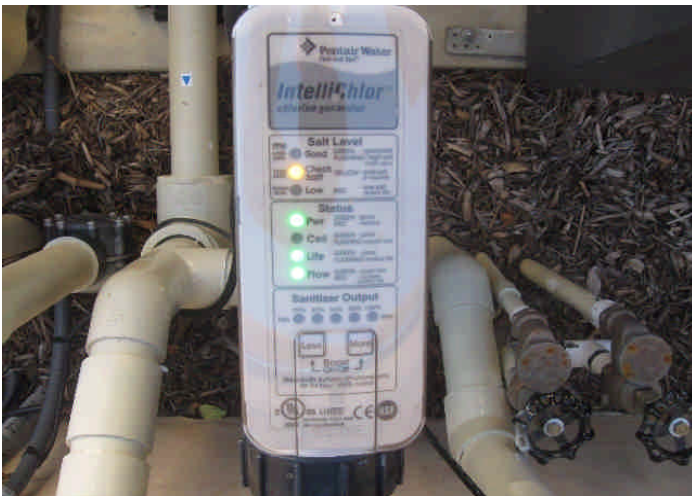
- Salt water system is not tested and is recommended to have the seller or a pool specialist demonstrate system servicing, maintenance and use. Remember, a salt water generator produces its own chlorine that is not as caustic as normal chlorine. The generator cell maintenance normally requires it to be replaced once or twice a year, refer to a pool specialist. Turbo generator cell in place without any apparent damage.
