# Americas Hometenders

## CONFIDENTIAL INSPECTION REPORT

1567 Catamaran Way, Laguna Niguel, CA

12/15/2009 2:00 pm to 6:00 pm

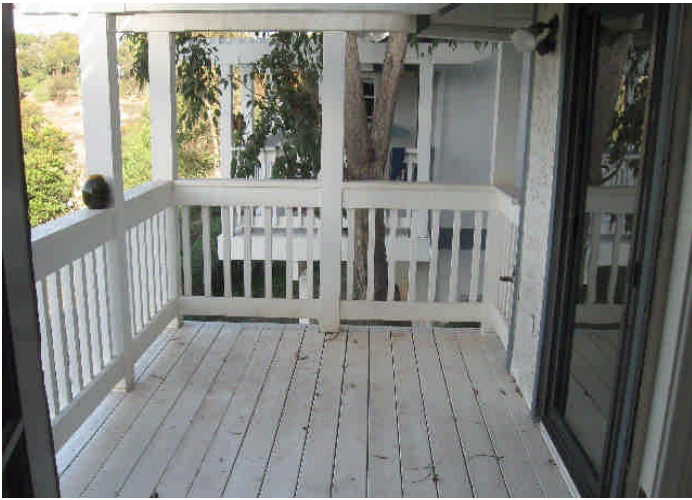
- The wood deck does not appear to have any apparent damage, and should be maintained and periodically sealed. Refer to the termite inspector for further investigation.

The wood deck is in acceptable condition - *Continued*

- Deck and stair railings current construction requirements are for 42 inches in height which is a recommended upgrade in structures built before 2008, however, a requirement in structures 2008 and after.  
*Components and Conditions Needing Service*
- The wood deck shade cover is properly anchored to the roof fascia board but the fascia board at the deck shade cover is not anchored to the rafter tails and is recommended to have the appropriate rafter tails Simpson bracket anchored to the fascia board to prevent possible displacement during winds or seismic activity.

1.4 - → The wood deck shade cover is properly anchored to the roof fascia board but the fascia board at the deck shade cover is not anchored to the rafter tails and is recommended to have the appropriate rafter tails Simpson bracket anchored to the fascia board to prevent possible displacement during winds or seismic activity.

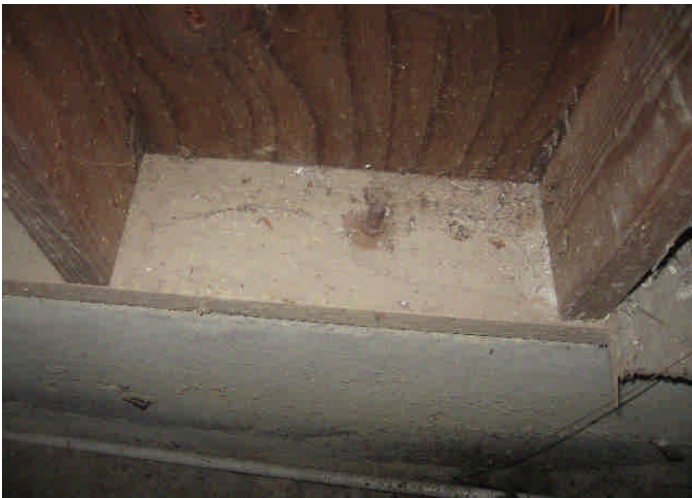
- Raised concrete foundation with bolts from walls to foundation typical of the time the structure was built were noted under the structure.

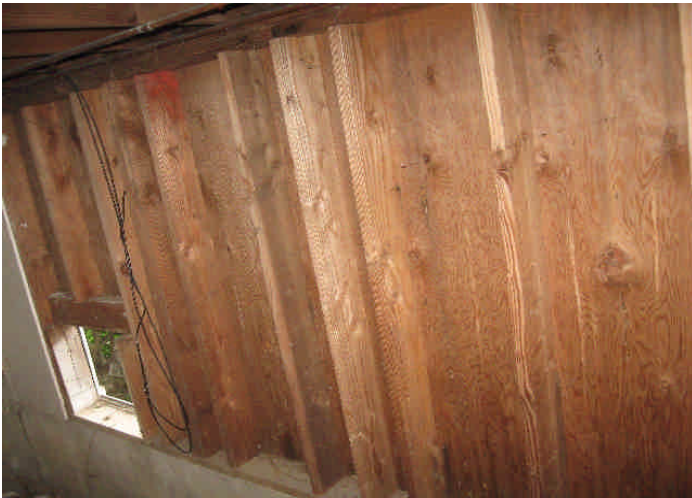
- The residence is constructed on a raised and bolted foundation with shear-paneled cripple walls. Plywood exterior shear bracing was noted on the cripple walls/tall walls under the home.

The residence is constructed on a raised and bolted foundation with shear-paneled cripple walls - *Continued*

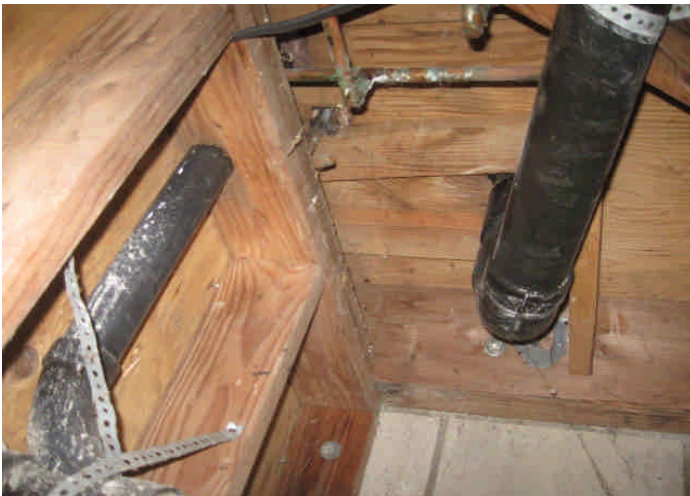
- There was no apparent leaking from the visible water supply or drain plumbing under the structure at the time of the inspection.

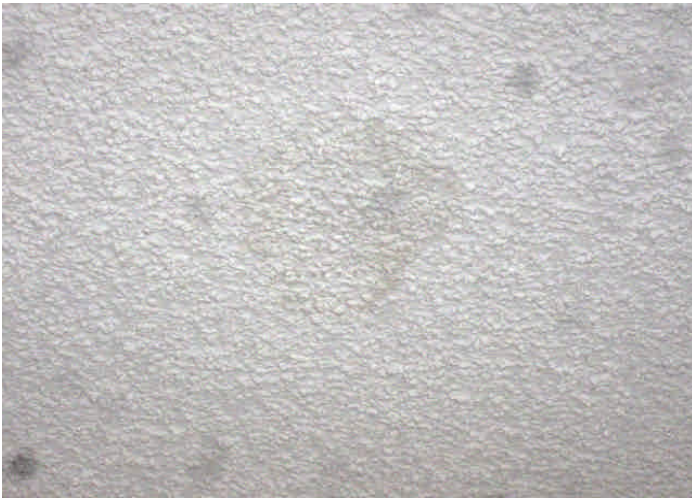
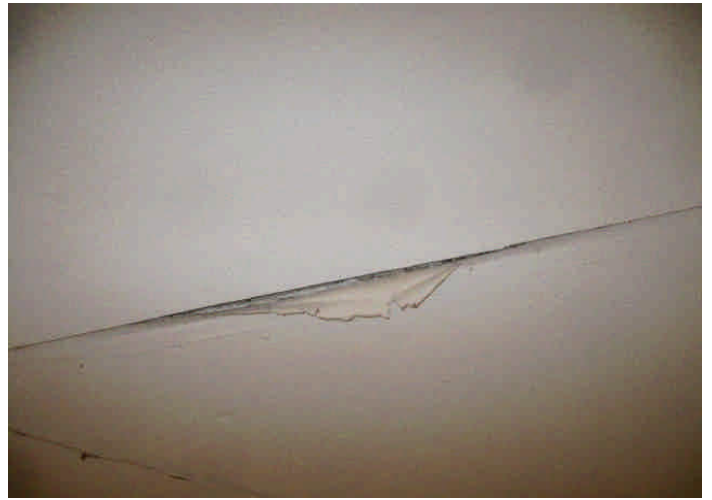
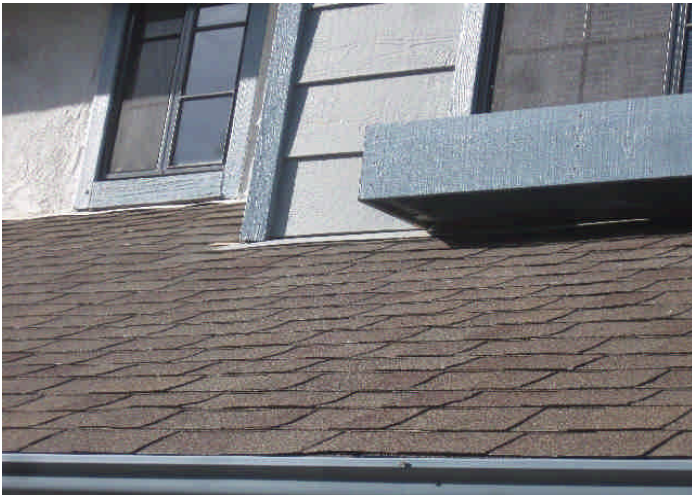
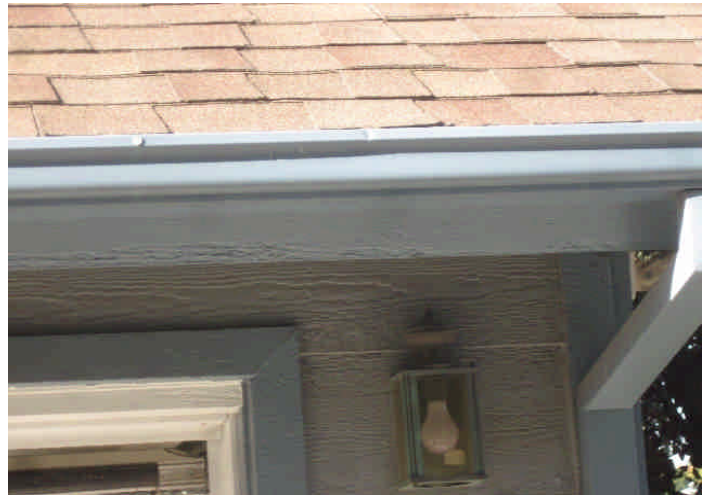
- The composition shingle roof appears to be approximately five to ten years old on a roof system that will normally last around 20 to 30 years with good maintenance, but this is just an estimate and you should request the installation permit from the HOA or obtain them from the City, which will reveal its exact age and any warranty guarantee that might be applicable. No apparent damage or current leaking was found at time of the inspection, however, dry stains were found in the living room ceiling and garage that maybe from the roof. Recommend further investigation to verify leaking and any moisture damage is properly corrected.

The composition shingle roof is layered and appears to be approximately five to ten years old - *Continued*

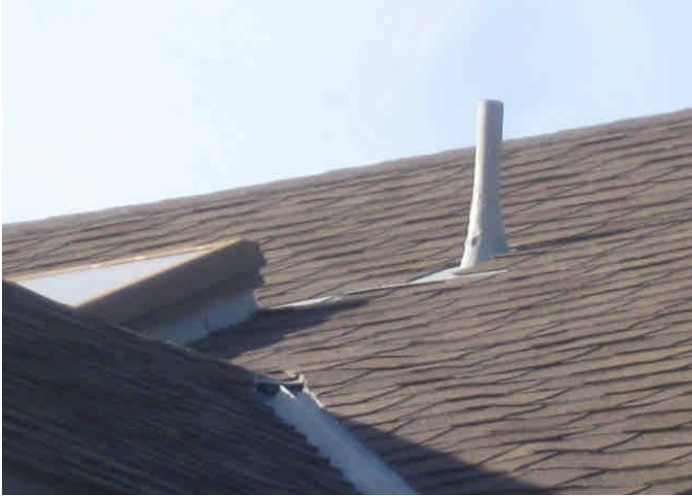
- The composition shingle roof includes one or more skylights, which are notoriously problematic and a common point of leaks. There are different methods of installing them and, although opinions will vary, some methods are better than others. Therefore, it will be important to keep the area around them clean and to monitor them for evidence of leaks.

The composition shingle roof includes skylights - *Continued*

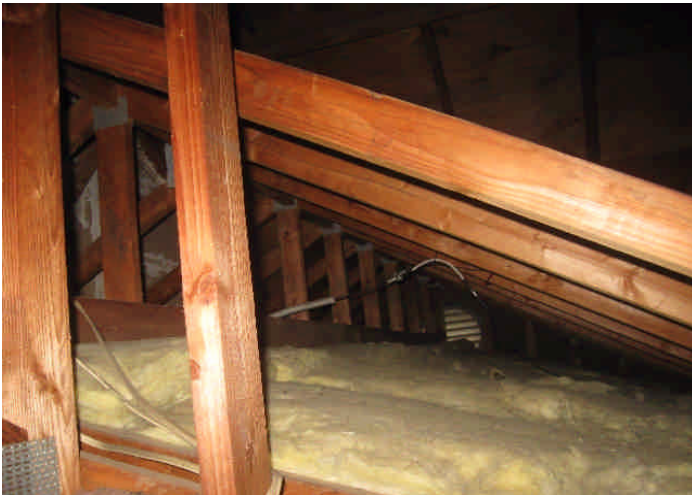
- The roof framing consists of a factory- built truss system, comprised of components called chords, webs, and struts that are connected by wood or metal gussets nailed or glued in place. Each component of the truss is designed for a specific purpose, and cannot be removed or modified without compromising the integrity of the entire strut. The lowest component, which is called the chord and to which the ceiling is attached, can move by thermal expansion and contraction and cause creaking sounds, which are more pronounced in the mornings and evenings along with temperature changes. Such movement has no structural significance, but can result in small cracks or divots in the drywall or plaster. No unusual movement or damage was found on the visible portions of the truss system at time of the inspection.

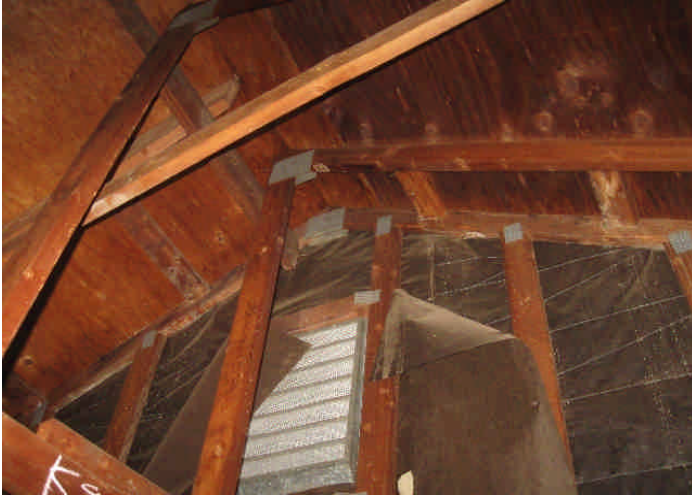
- Ventilation within the attic is provided by a combination of eave, dormer, turbine, or gable vents, and should be adequate.

Ventilation within the attic appears to be adequate - *Continued*

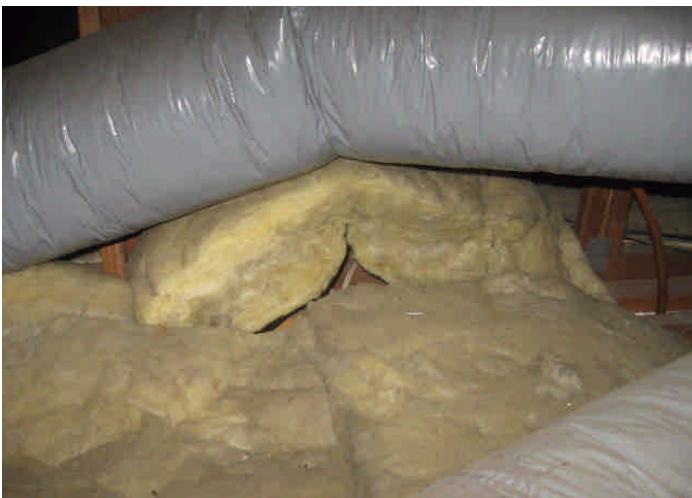
- The attic floor is well insulated with approximately nine-inches of fiberglass, batt insulation.

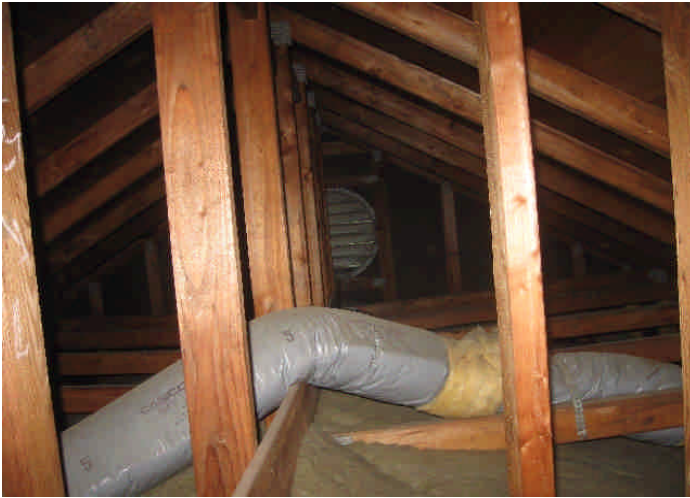
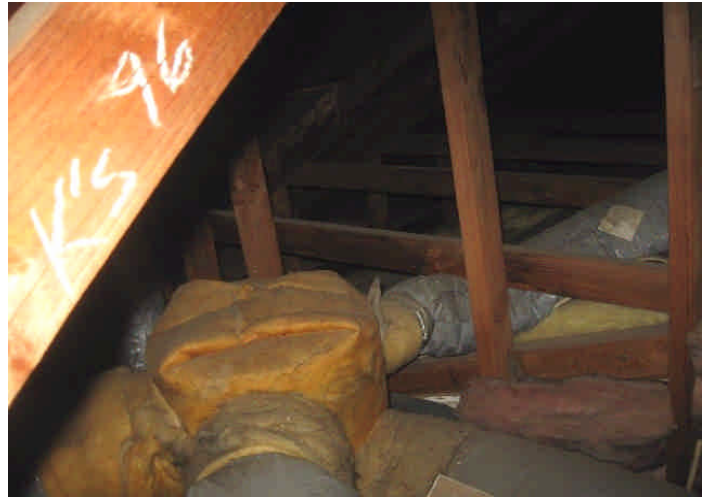
- The visible heating-cooling ducts in the attic did not appear to have any damage at time of the inspection.

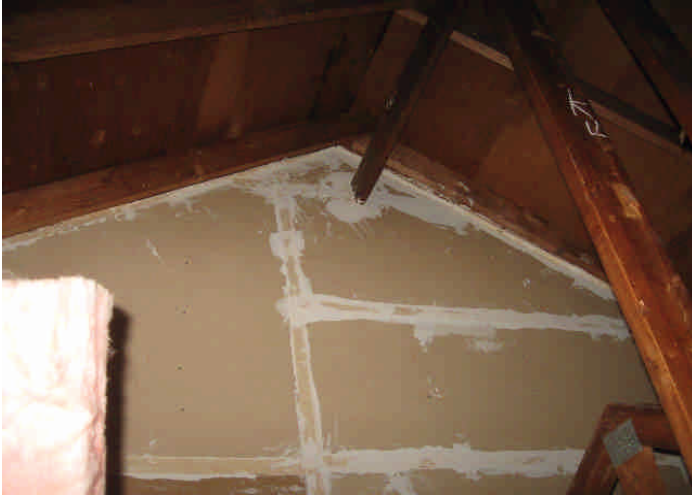
- The condominium-town home attic has firewall-security protection between units.

The condominium-town home attic has firewall-security protection between units - *Continued*

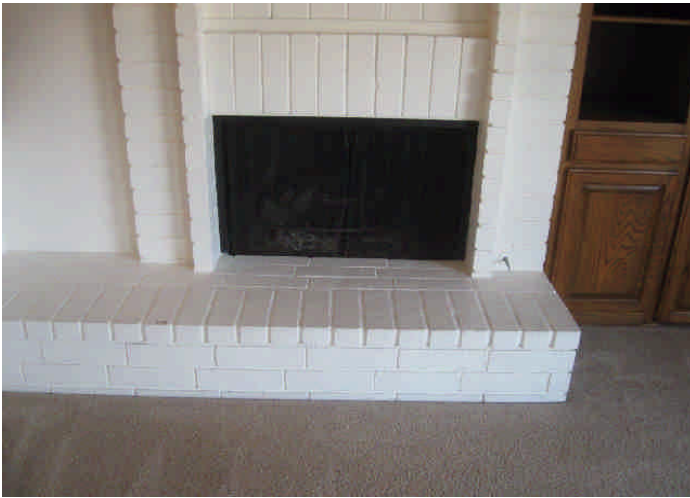
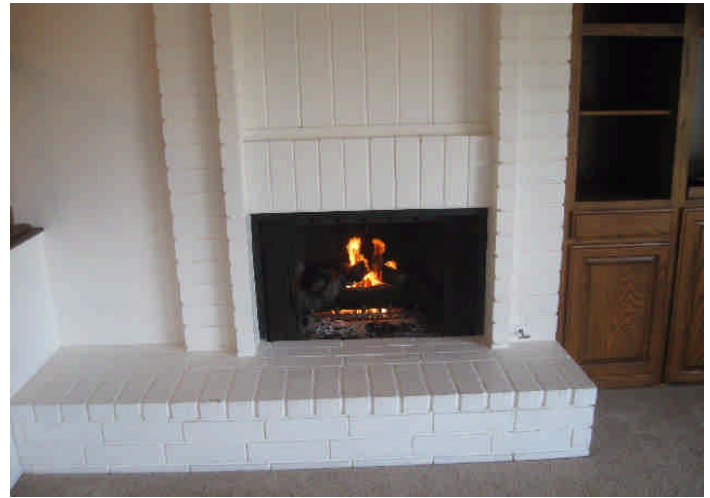
- The fireplace did not appear to have any unusual displacement or damage, clearance to combustibles appeared adequate on visible portions of the fireplace, the hearth was in place.

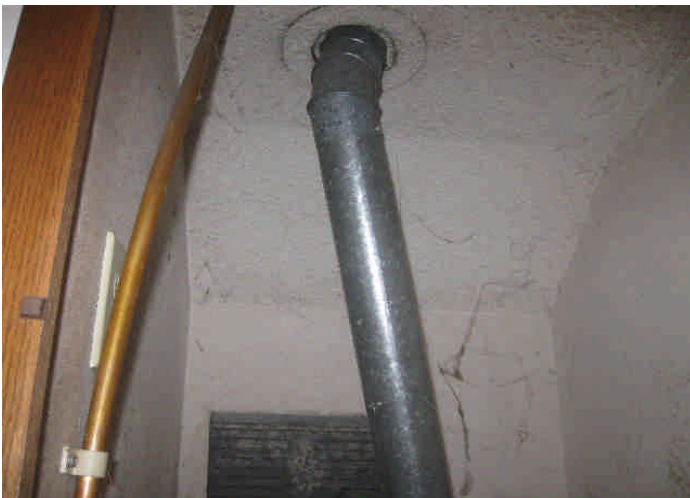
- The gas vent pipe was in place and did not appear to be back venting or too close to combustibles and it was properly secured with screws at joints.

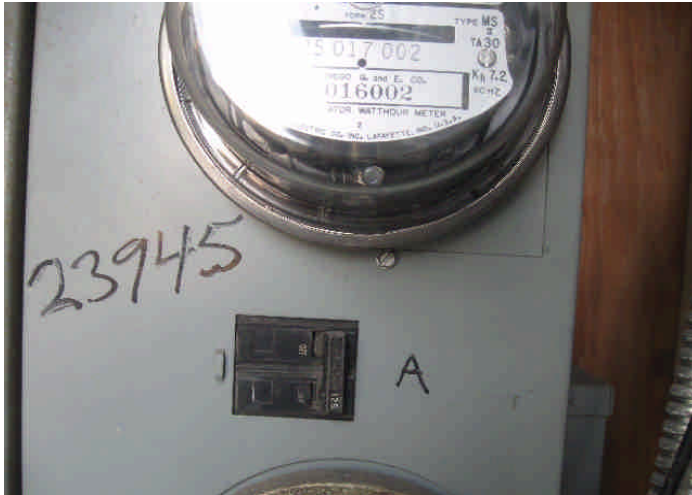
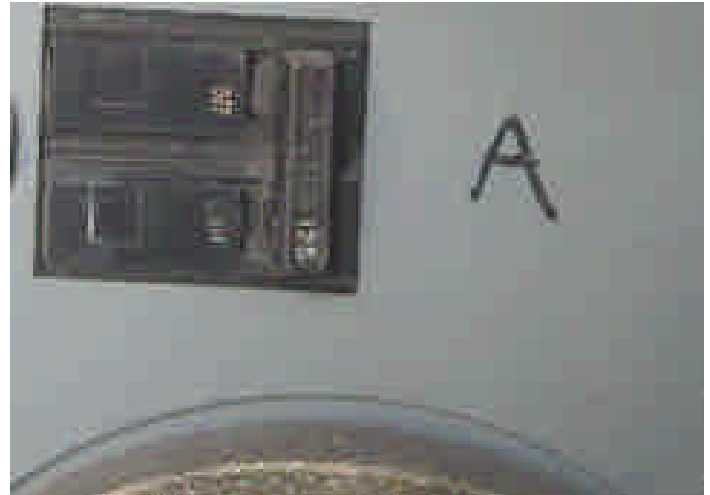
- The main electrical panel is located in an exterior closet and has a 125 main breaker with 240\120 volts.

The main electrical panel is located in an exterior closet - *Continued*

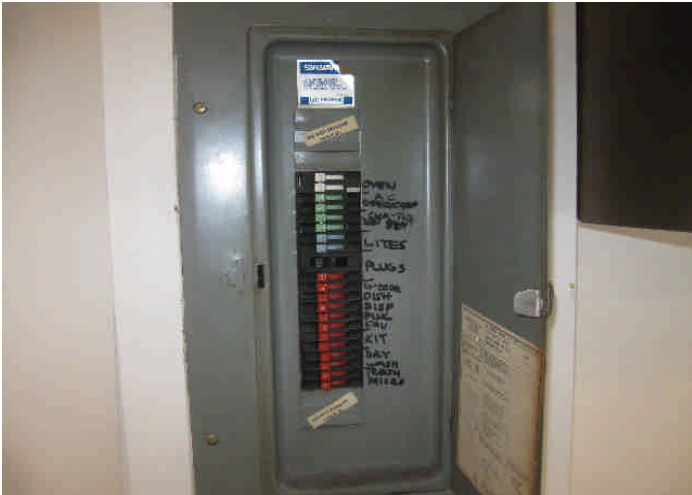
- The interior cover of the electrical sub panel did not have any unusual damage.

The interior cover of the electrical sub panel is in acceptable condition - *Continued*

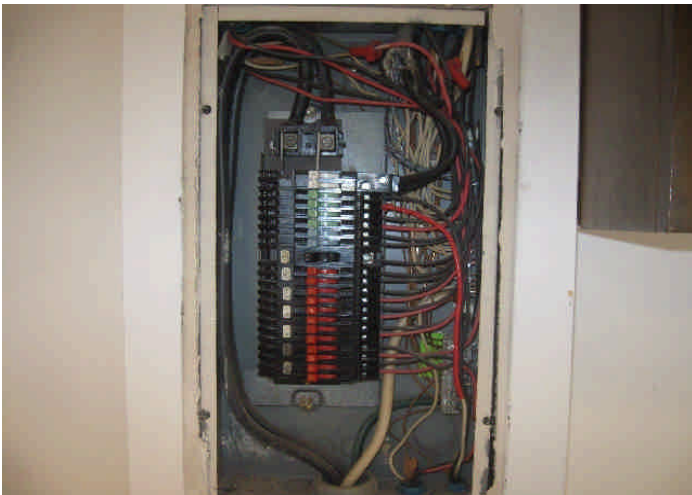
- The circuit breakers within the sub panel have no visible deficiencies and appears to be installed with specifications that are acceptable to the period the building was built in.

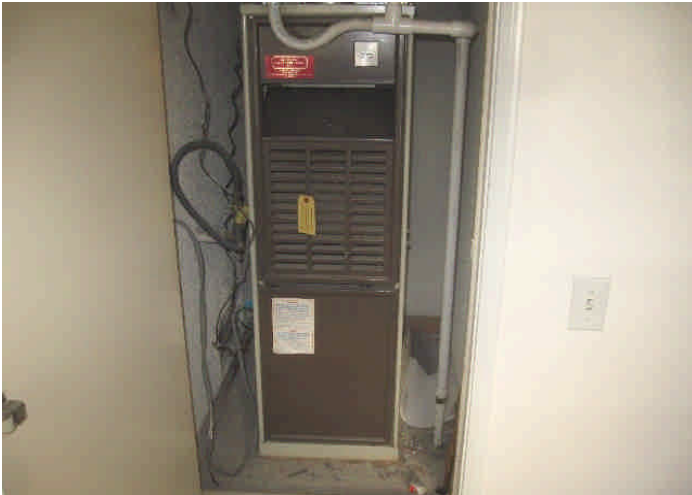
- The furnace turned on and off on demand at the time of the inspection and was producing heat at the registers.

The furnace was producing heat - *Continued*
