Americas Hometenders

CONFIDENTIAL INSPECTION REPORT

2014 Old Ranch Road, Laguna Niguel, CA

12/23/2009 10:00 am to 1:30 pm

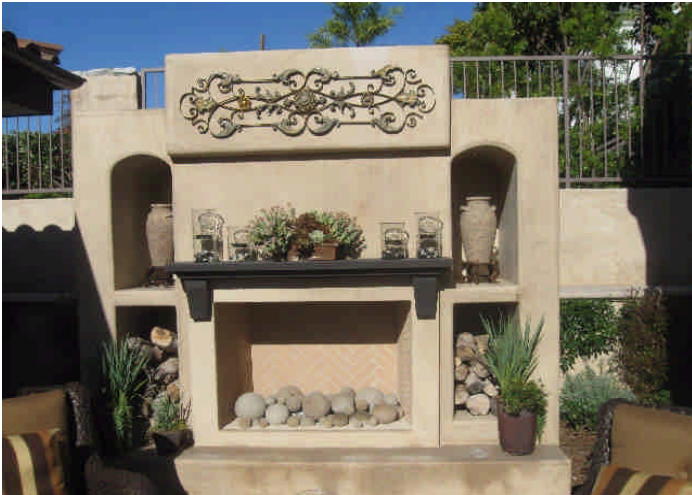
- Gas ceramic logs were in use and the gas turned on during the inspection.

Gas ceramic logs were in use and the gas turned on during the inspection - *Continued*

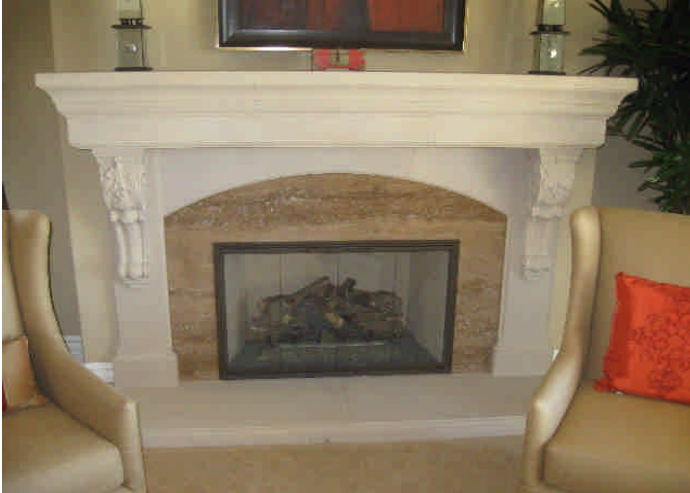
- The fireplace did not appear to have any unusual displacement or damage, clearance to combustibles appeared adequate on visible portions of the fireplace, the hearth was in place.

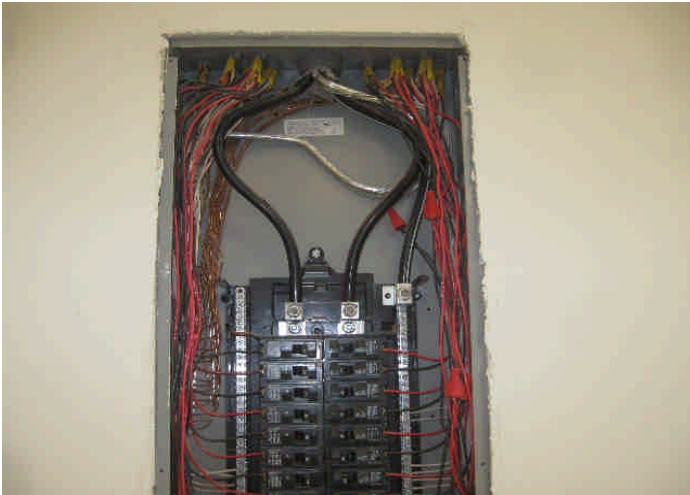
- The electric sub panel had no visible damage, burnt wires or broken breakers.

The electrical sub panel has no visible deficiencies - *Continued*

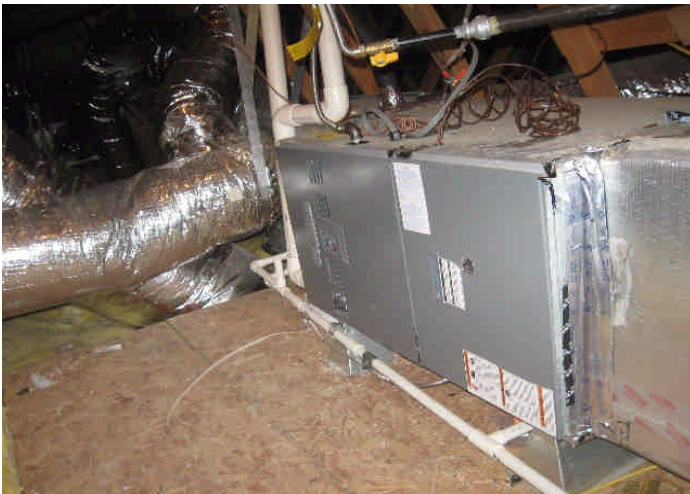
- The furnace turned on and off on demand at the time of the inspection and was producing heat at the registers.

The furnace was producing heat - *Continued*

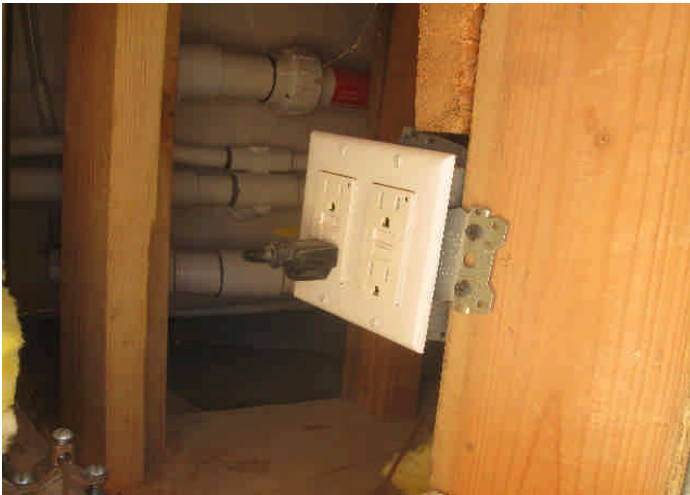
- The spa tub/shower was filled and turned on to verify the motor/pump was functioning which responded to the switch, the GFCI protection and bond wire for the pump were found in the exterior access.

The hydro-spa is functional - *Continued*

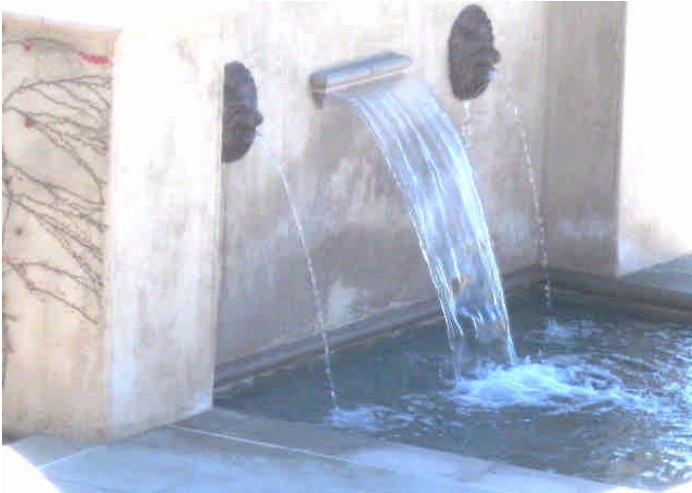
- Water fall responded to the controls.
